Confidential Inspection Report

LOCATED AT:
123 Sample Street
Sample Town, New Jersey 07080

INSPECTED ON:
Monday, January 01, 2018

Inspector, Mikhail Potros, P.E., CPI 24GI00173700
Precision Home Inspections LLC

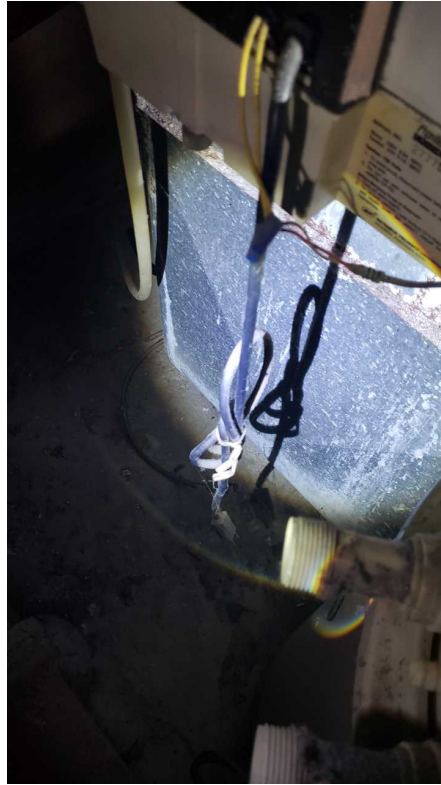
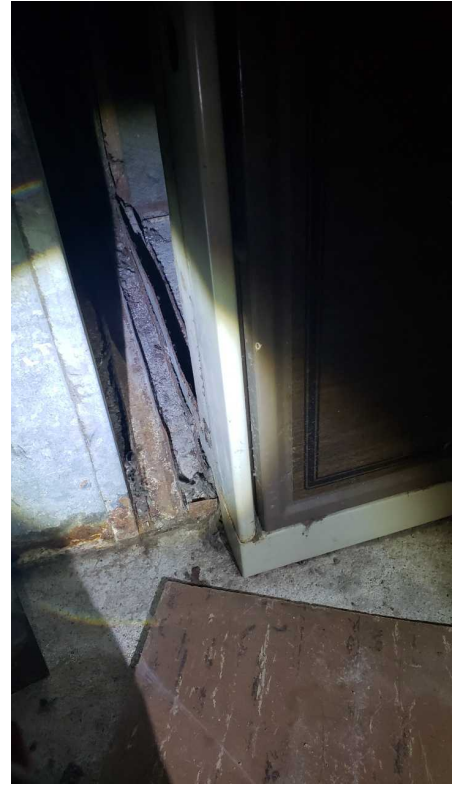
WARN UPG 6: - The return duct as well as bottom portions of the furnace unit showed significant signs of corrosion. This may have resulted from a previous humidifier leak. At the time of the inspection the humidifier was unplugged and drain line was cut. Further evaluation by a qualified licensed HVAC contractor is recommended.

The return duct as well as bottom portions of the furnace unit showed significant signs of corrosion. This may have resulted from a previous humidifier leak. At the time of the inspection the humidifier was unplugged and drain line was cut. Further evaluation by a qualified licensed HVAC contractor is recommended.

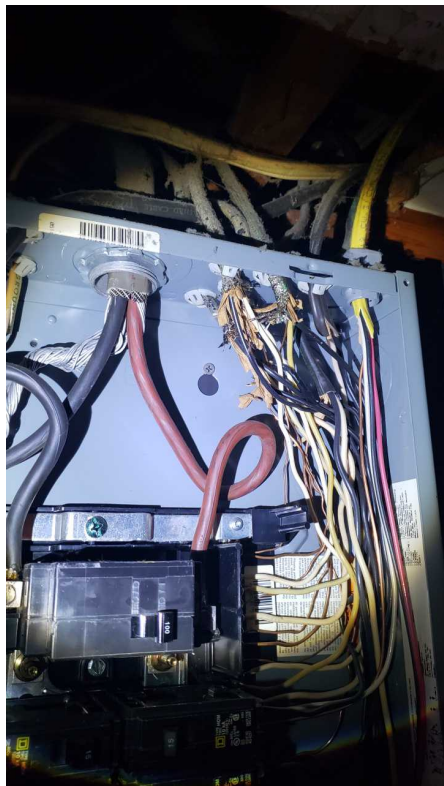
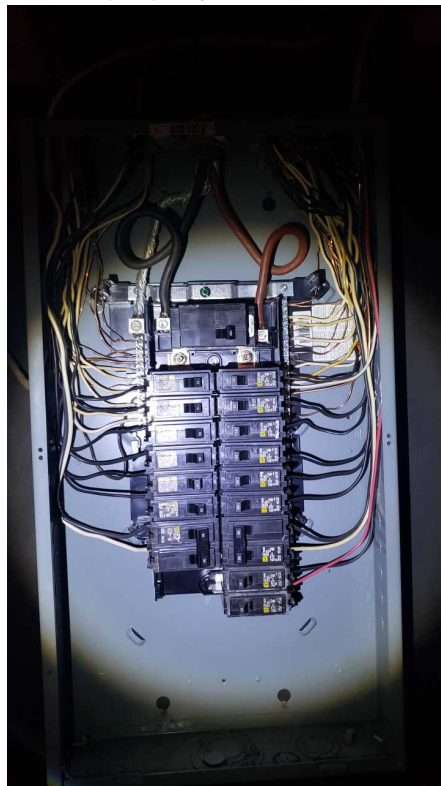
CB MAIN PANEL

The main service panel is in serviceable condition with circuitry generally installed and fused correctly, however service entrance cables should be properly secured above the service panel.

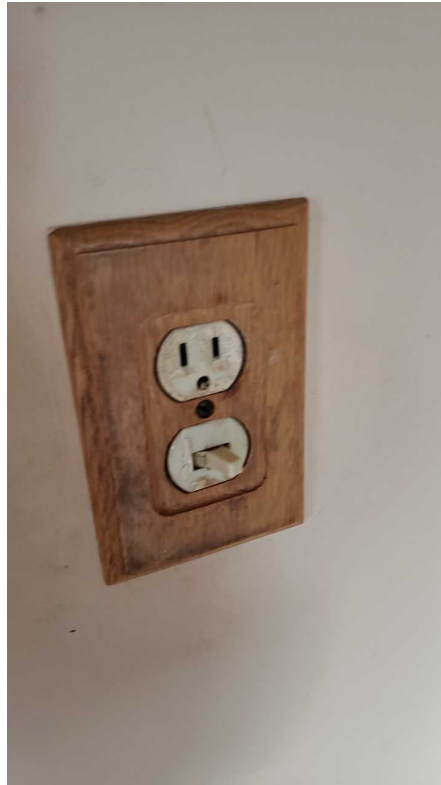
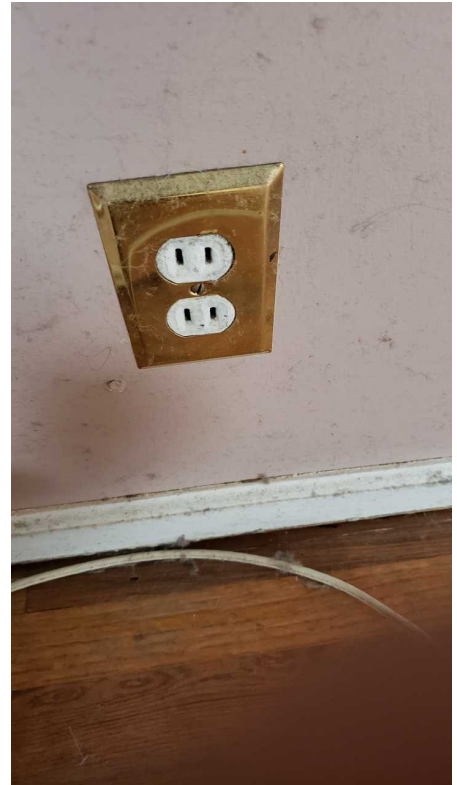
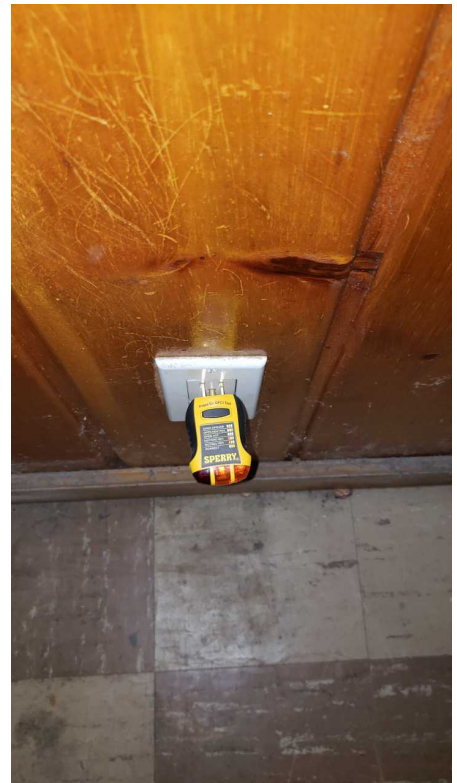
WARN **UPG** The receptacles throughout the structure are a combination of 2-wire and 3-wire types, with grounded and ungrounded circuitry, indicating installation at different times. The tested receptacles properly matched their wire type although upgrade of 2 prong receptacles to include grounding is recommended.

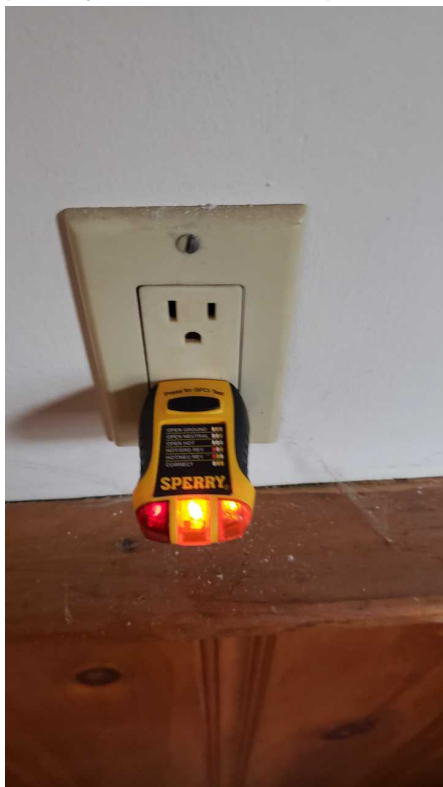
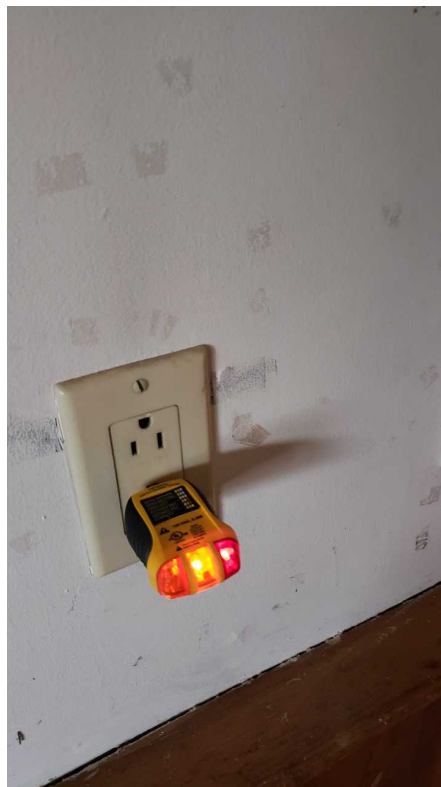
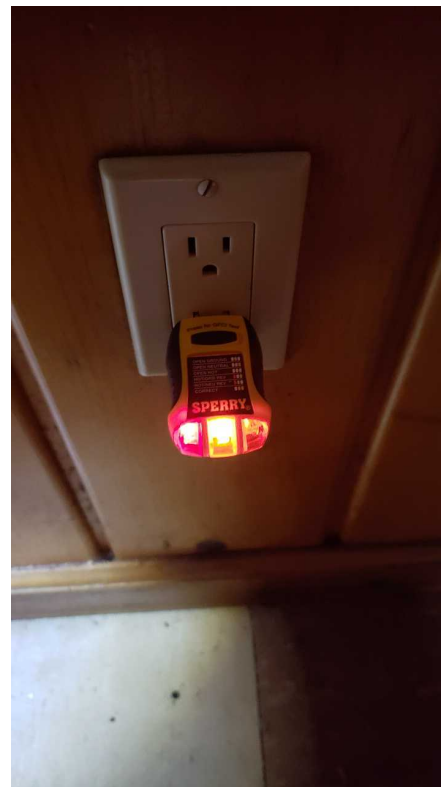
UPG A number of receptacles have been wired with reversed polarity. This creates a shock and short hazard and these receptacles should be repaired. We recommend all receptacles be checked for correct polarity, identified and repaired.

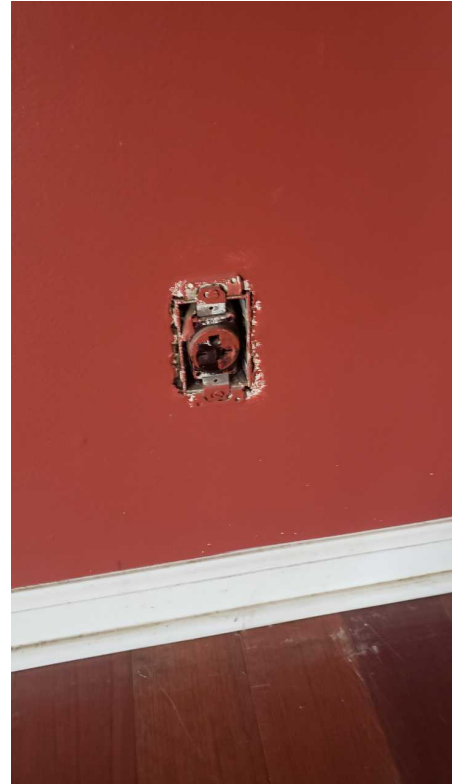
UPG Some of the receptacles are missing cover plates. We recommend they be replaced in the course of maintenance to reduce the risk of electrical shorts and hazardous shocks.

For attention to the condition(s) noted above, and/or cost estimates, if necessary, we recommend the advice and services of a licensed electrical contractor.

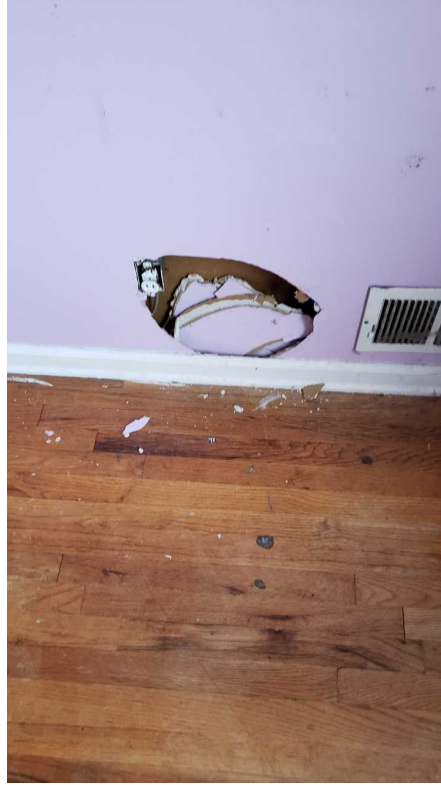
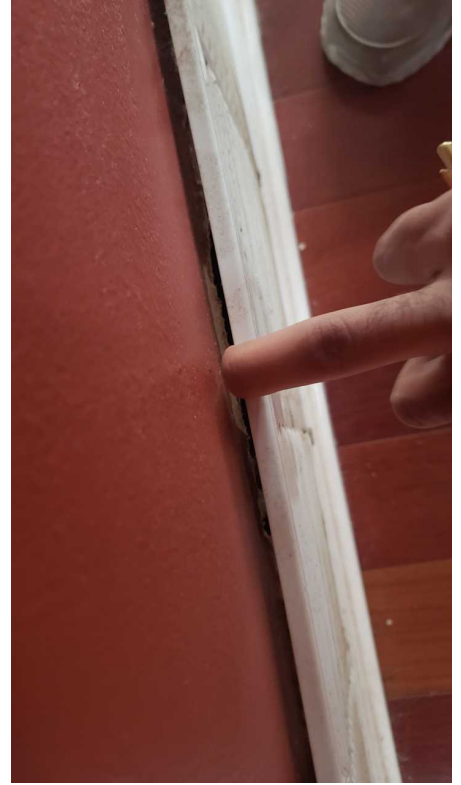
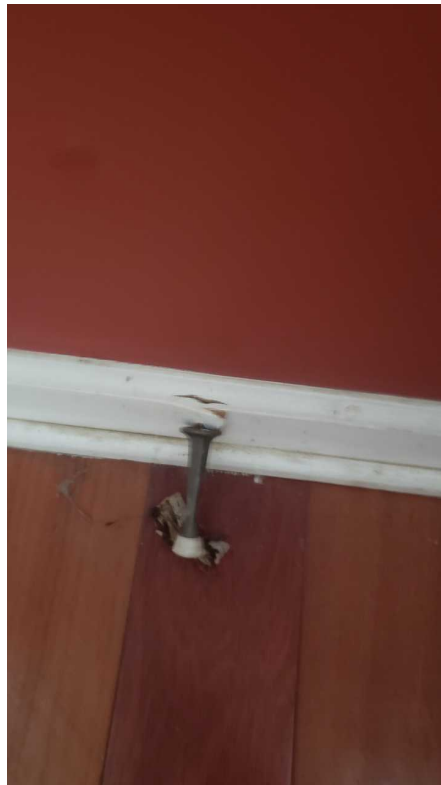
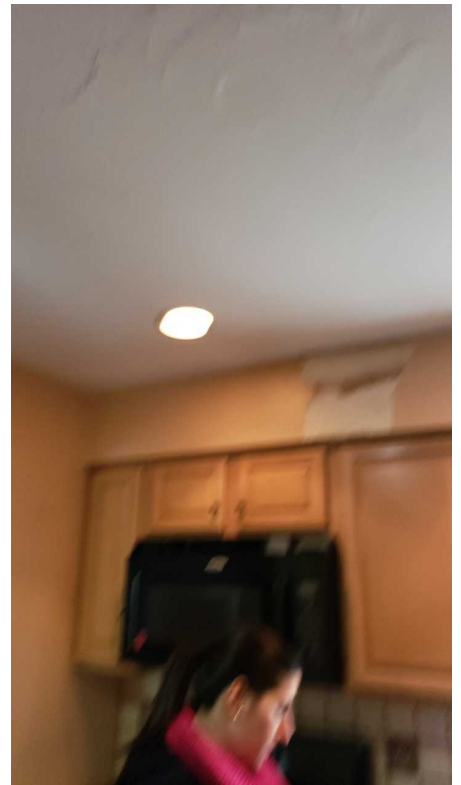
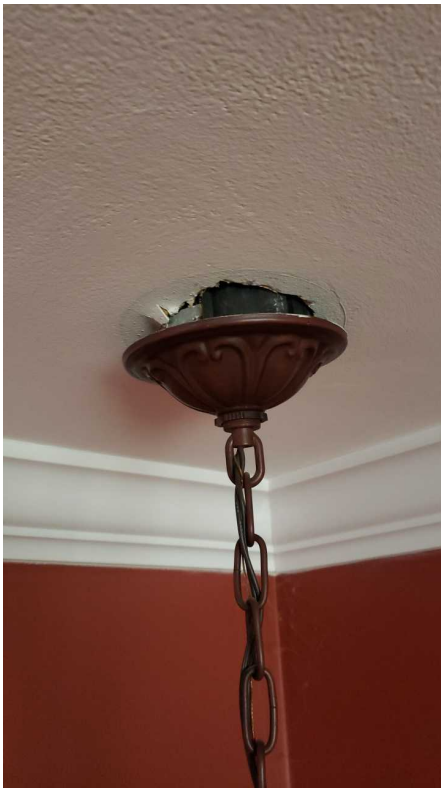
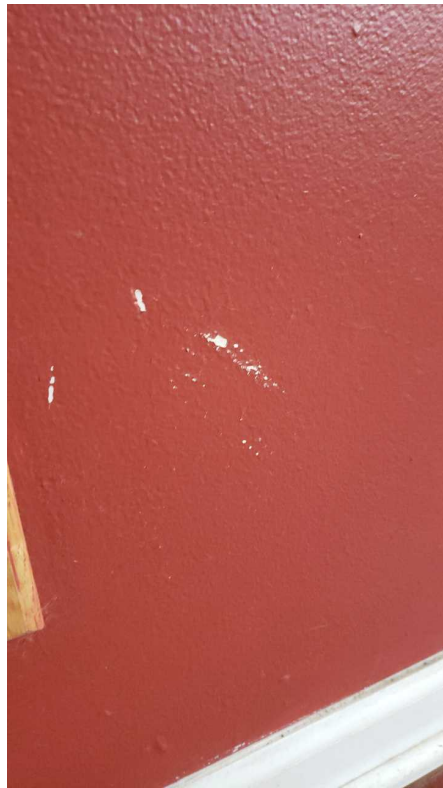
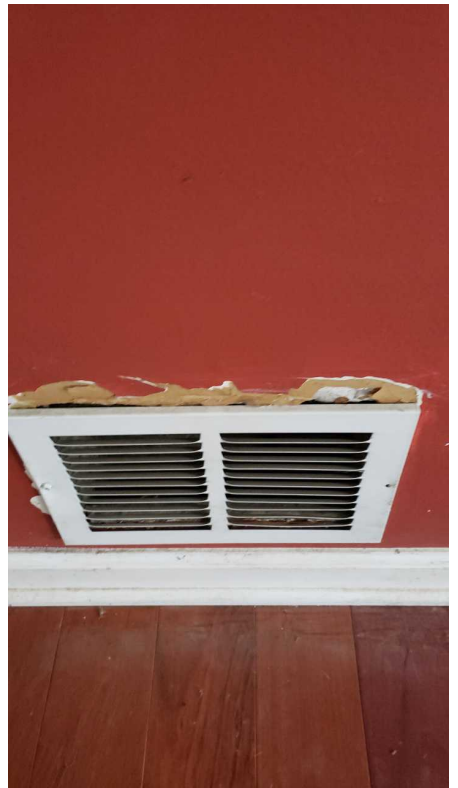
UPG There are minor cracks in the walls and/or ceilings. This is a common condition with this type of construction and does not indicate a structural deficiency. The cracks should be repaired and painted over.

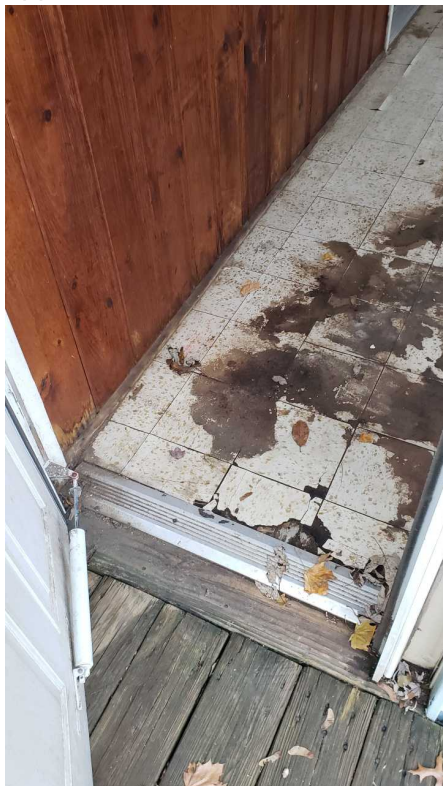
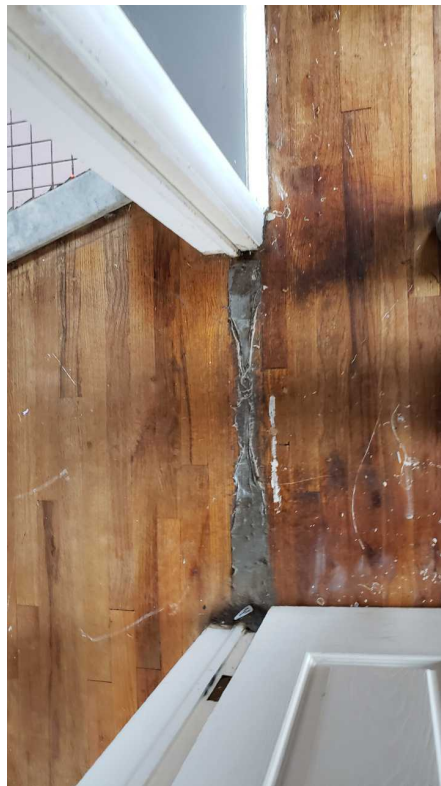
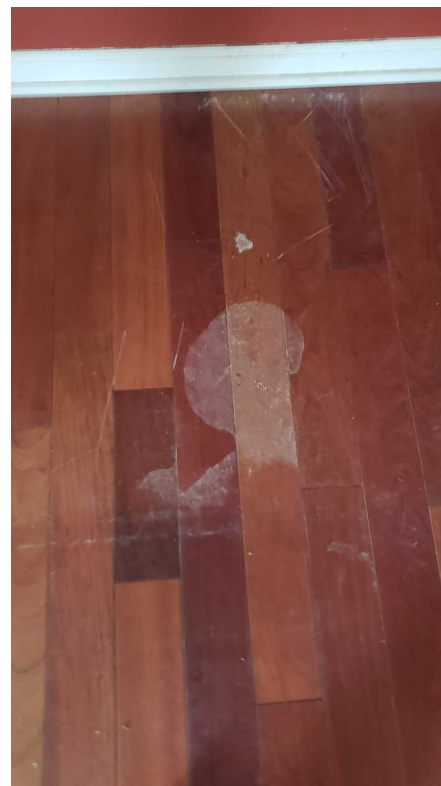
Portions of the floors are worn. We recommend refinishing to protect the wood and for a better appearance.

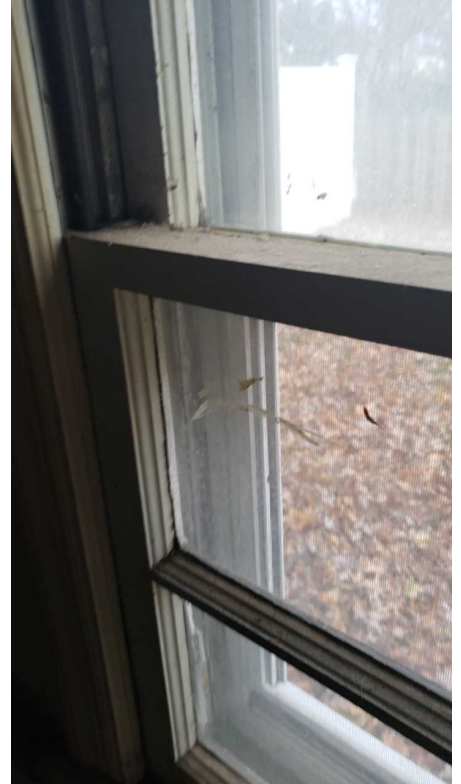
Window doesn't remain open. Broken latches

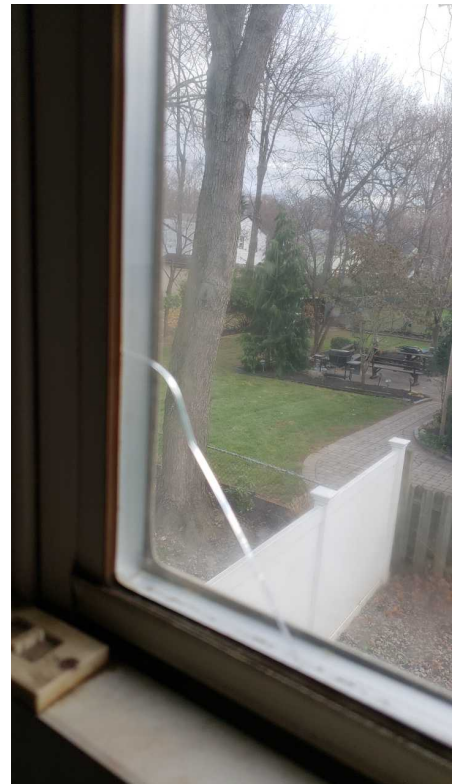
Windows in the rear sunroom are difficult to open

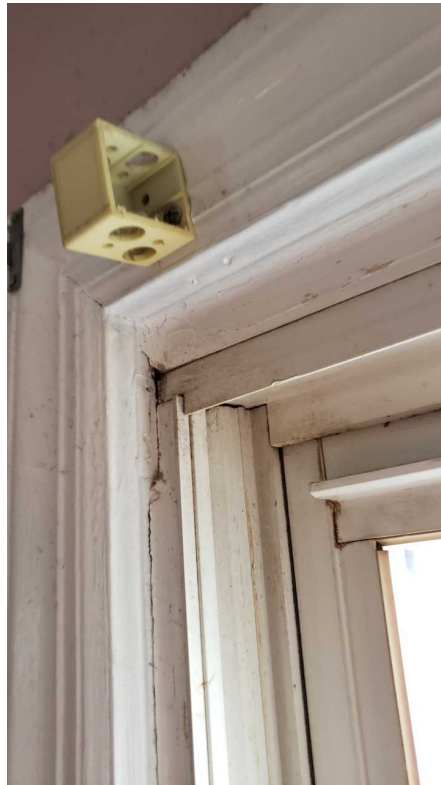
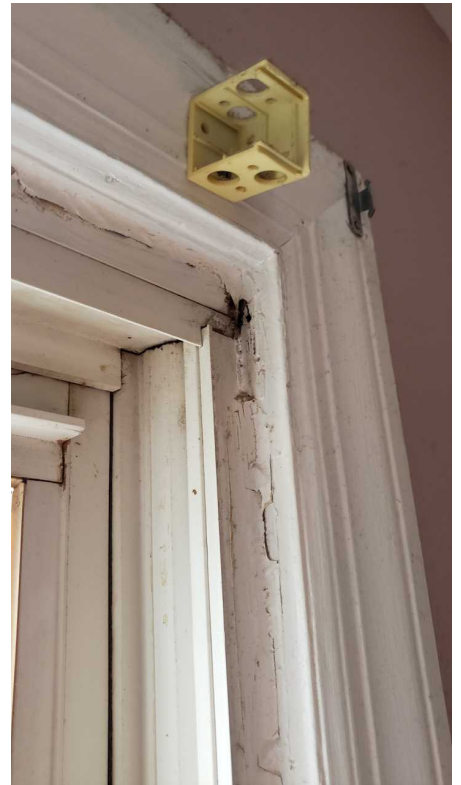
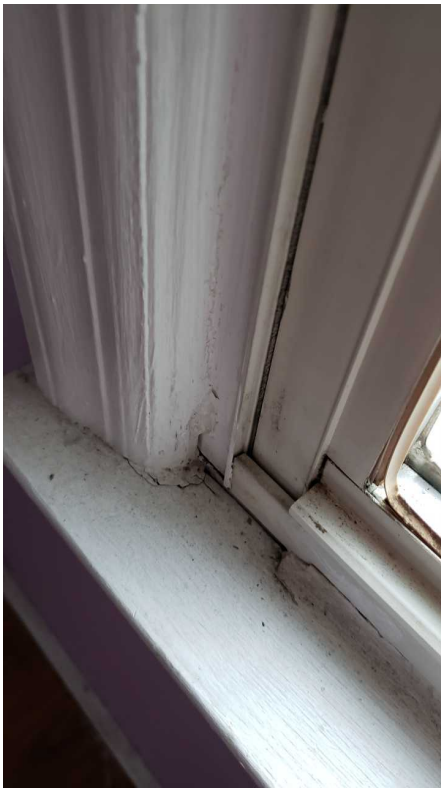
Screens and joints on several of the windows are slightly damaged and or missing. We recommend they be repaired or replaced.

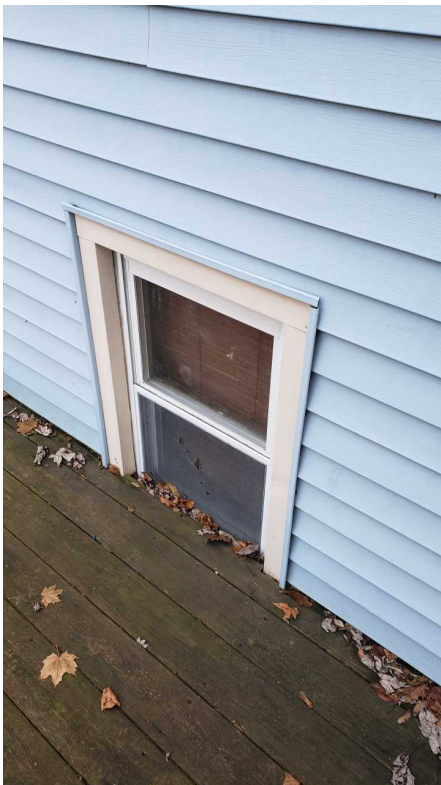
The window in the lower level bathroom is in a very bad location and shows previous entrance of debris, leaves, and moisture runoff from the adjacent deck.

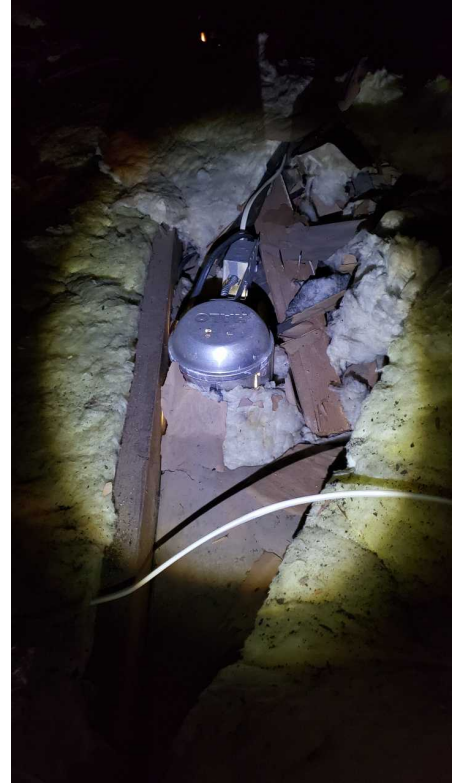
The recessed lights are covered with insulation and are a potential fire hazard. We recommend that barriers be provided over and around the lights in accordance with local standards and manufacturer's specifications and/or replace bulbs with newer LED lights.

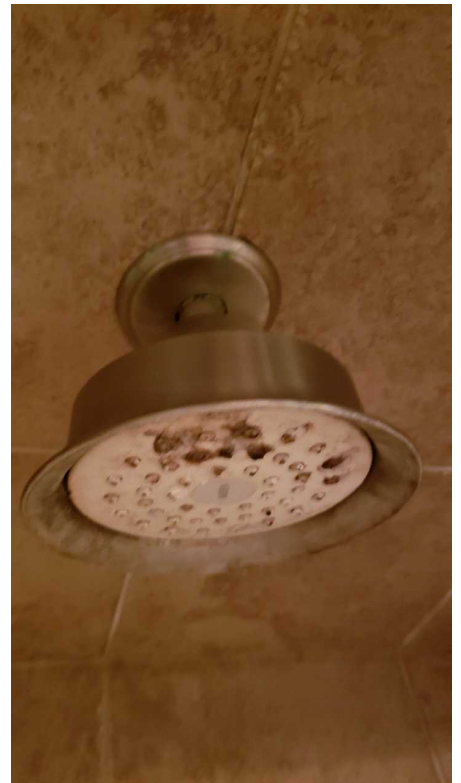
Clogged and stained

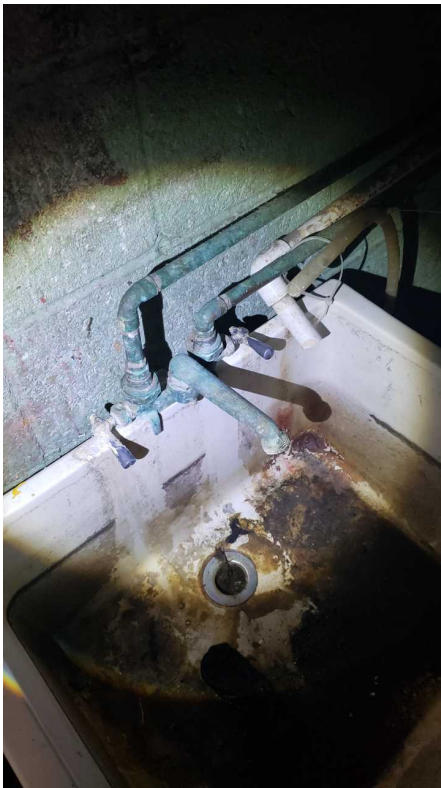
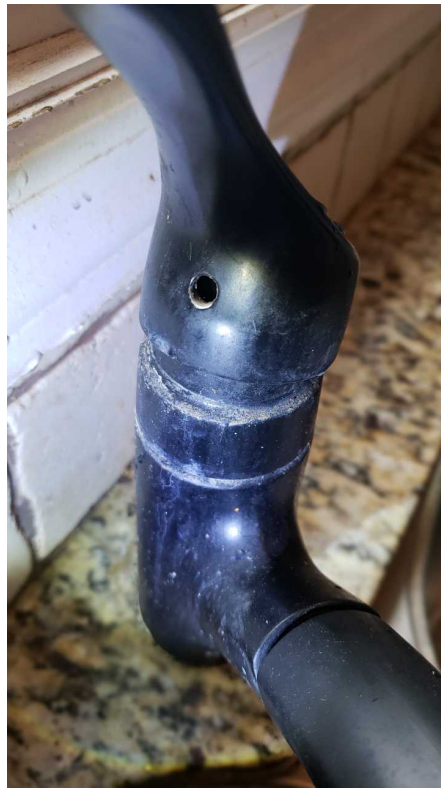
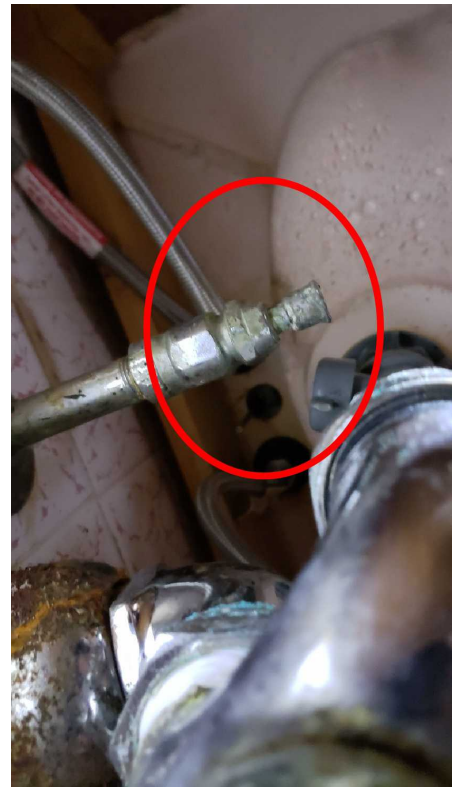
UPG The plumbing fixtures, although operating, are deteriorated and in need of replacement. Kitchen sink has hot water reversed. And bathroom fixtures show signs of corrosion/oxidation, mildew, and missing /broken valve controls. Routine maintenance will keep them functional and maximize their useful life.

Missing valve handle

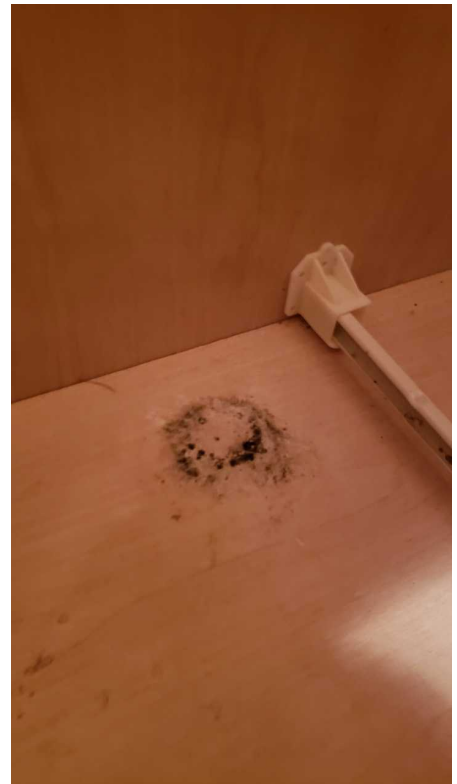
Corrosion on drain

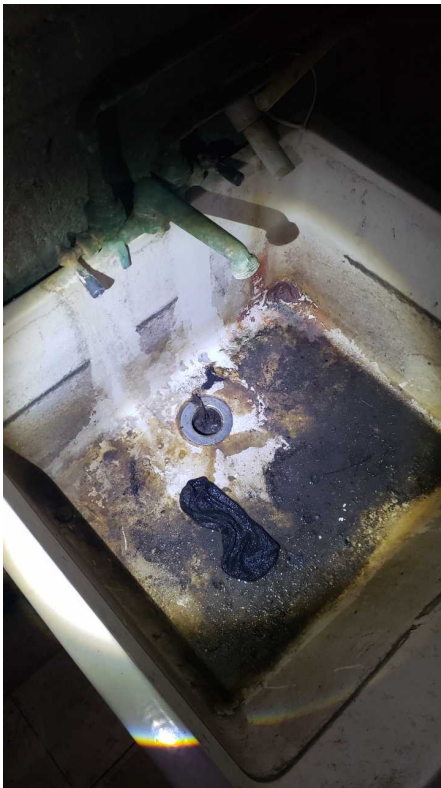
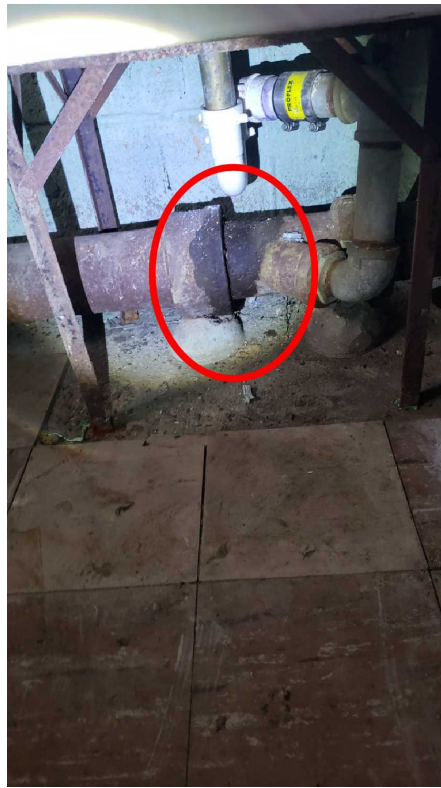
Previous leak

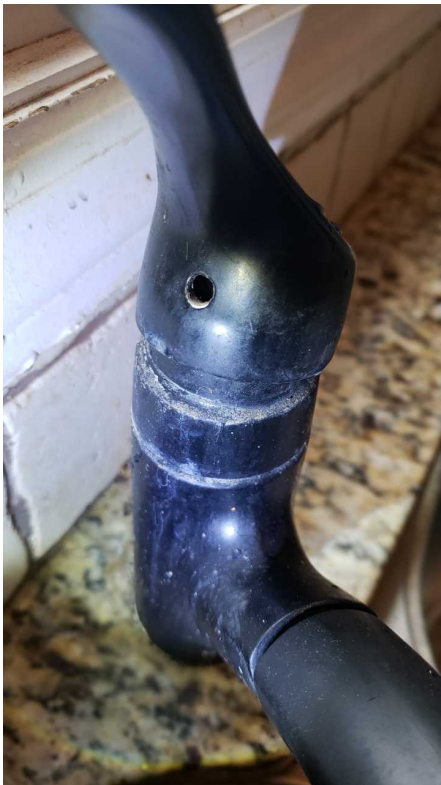
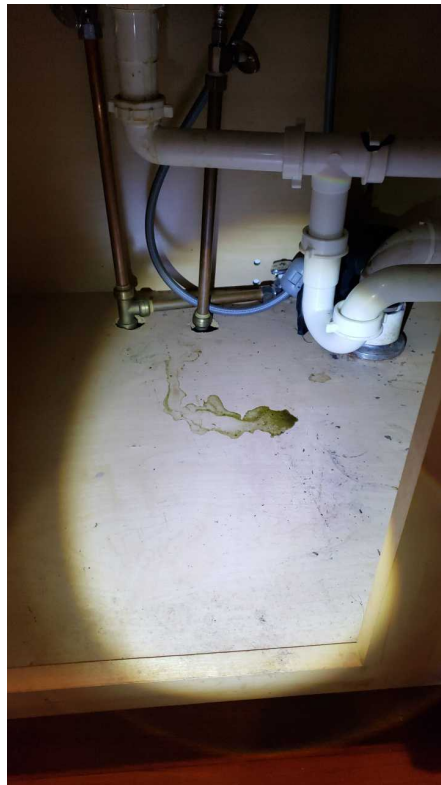
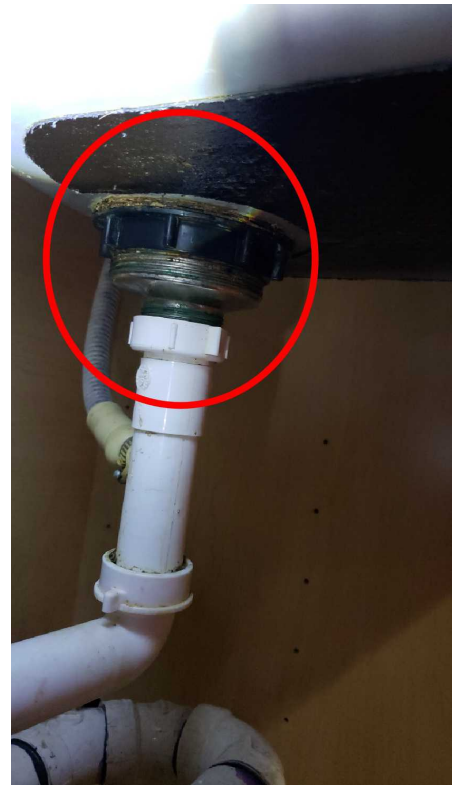
Corrosion on supply lines in kitchen

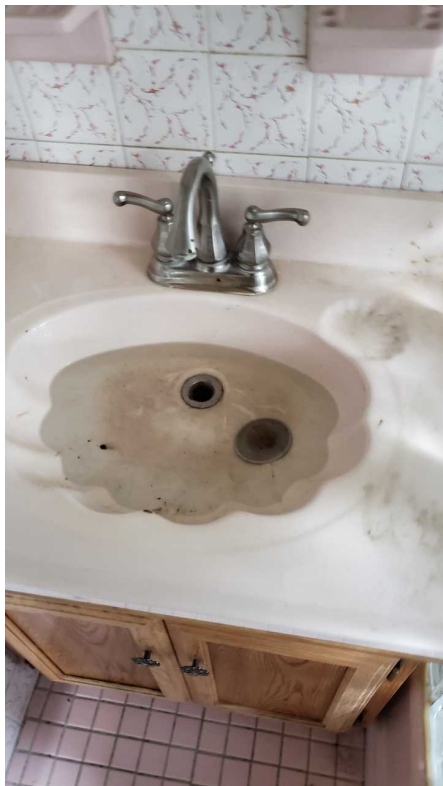
The drain observed in the bathroom is slow to drain, indicating possible obstruction. We recommend the piping be cleaned to allow free-flowing drainage.

For attention to the condition(s) noted above, we recommend the advice and services of a licensed plumbing contractor.

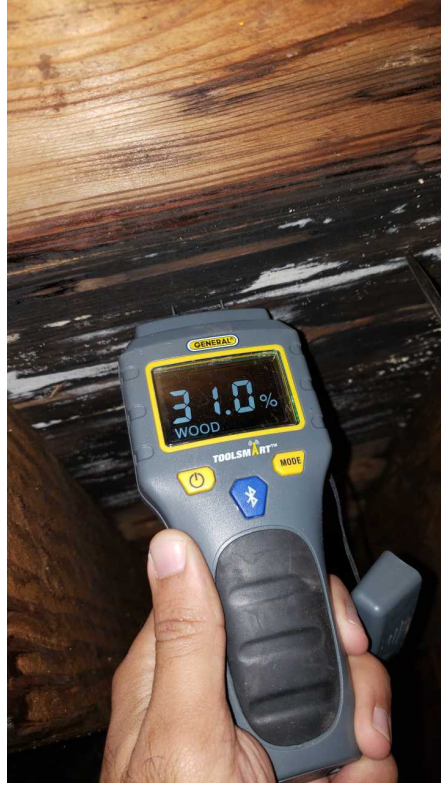
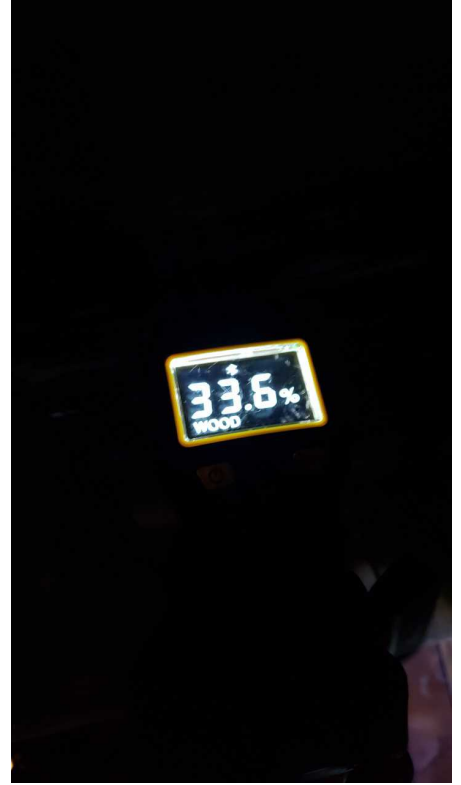
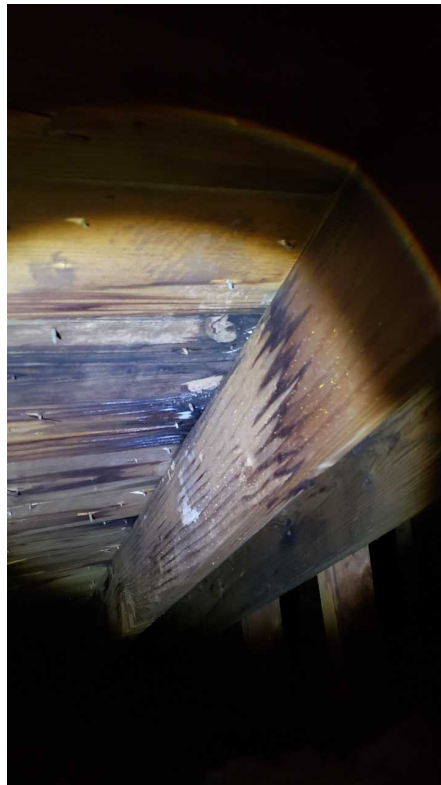
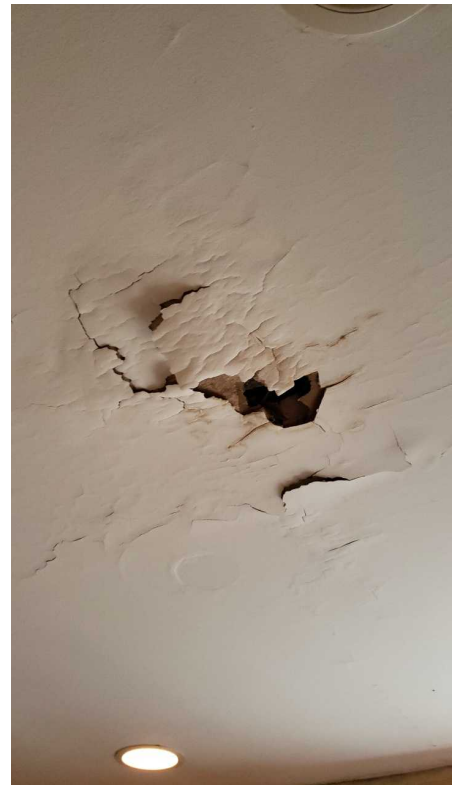
WARN UPG 14: - In addition to the condition(s) noted, there is evidence of leakage on the underside of the roof. The source of the leak should be found and repaired. We recommend the advice and services of a licensed roofing contractor.

In addition to the condition(s) noted, there is evidence of leakage on the underside of the roof. The source of the leak should be found and repaired. We recommend the advice and services of a licensed roofing contractor.

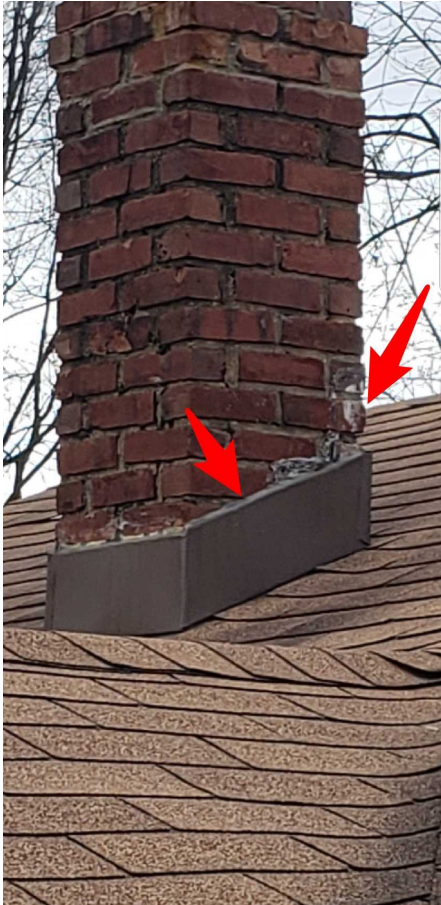
UPG 15: - The counter flashing at the chimney was installed in a substandard manner. The counter flashing should be installed directly into the mortar joints and, in our opinion, is currently substandard. We recommend it be removed and repaired by a qualified and licensed chimney contractor.

UPG The counter flashing at the chimney was installed in a substandard manner. The counter flashing should be installed directly into the mortar joints and, in our opinion, is currently substandard. We recommend it be removed and repaired by a qualified and licensed chimney contractor.

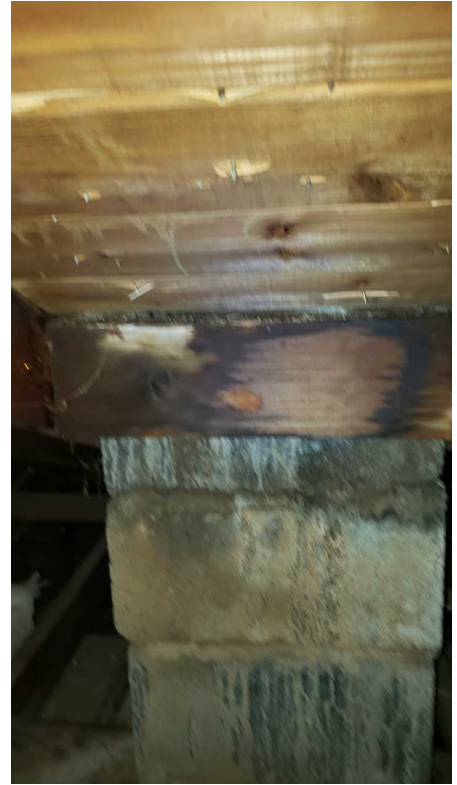
High moisture reading

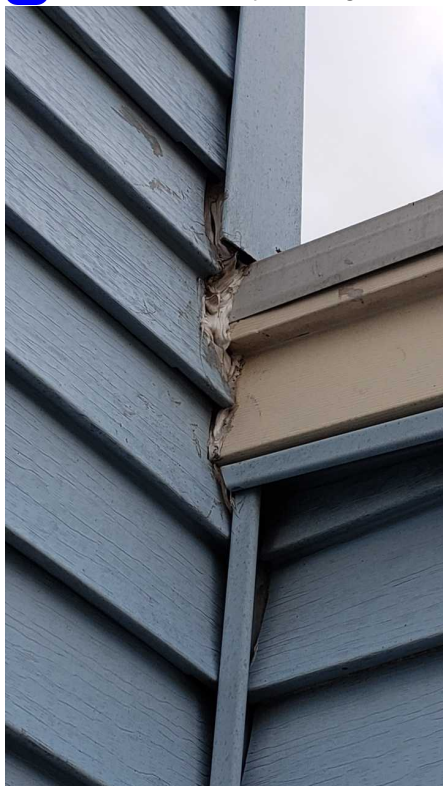
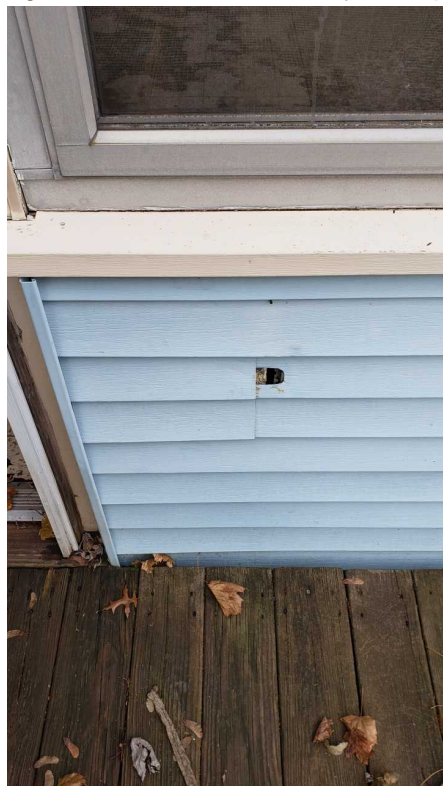
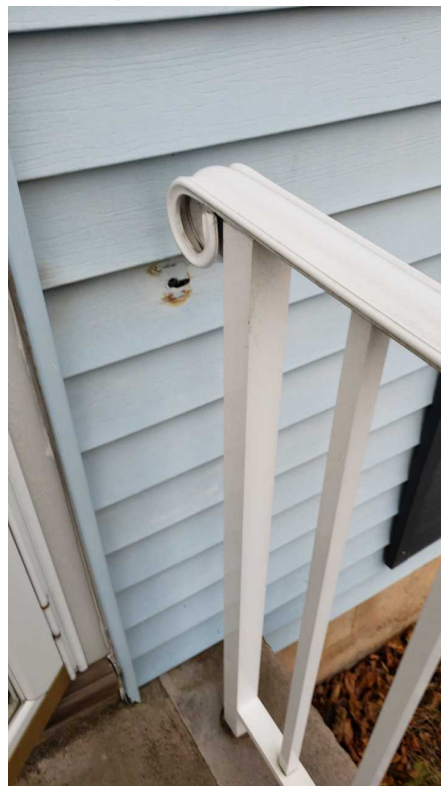
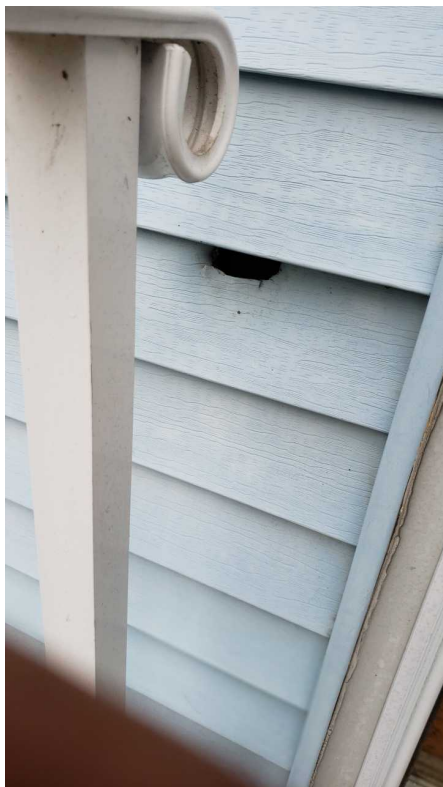
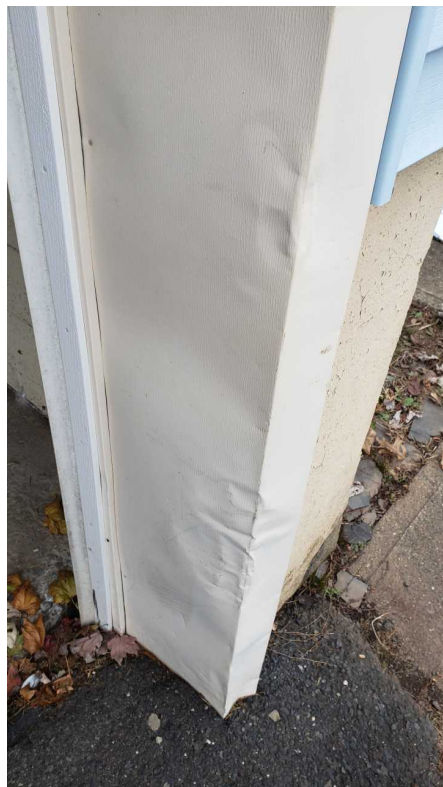
UPG Sections of vinyl siding are damaged. We recommend they be repaired or replaced.

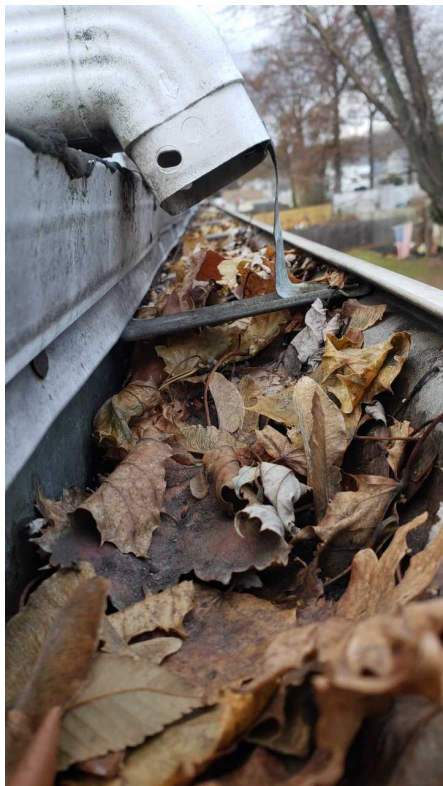
The gutters are filled with debris. We recommend all debris be removed to ensure proper drainage. The condition of the gutters can be better assessed at that time.

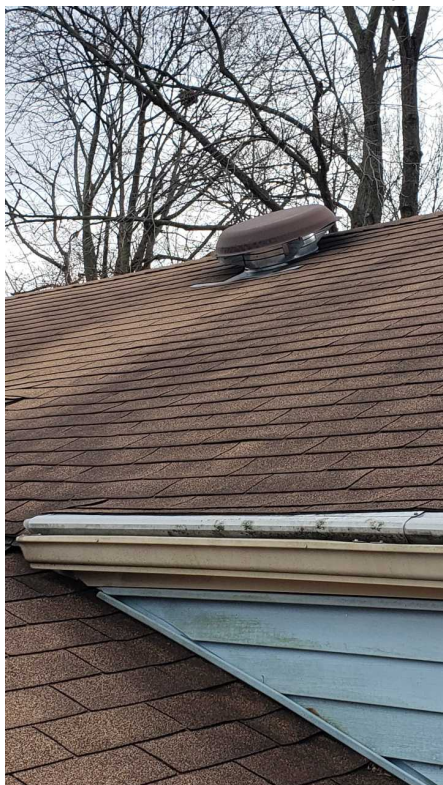
UPG 16: - The gutter at the split roof is not draining properly because they are improperly sloped. The gutter should be reconfigured or an additional downspout should be installed. If not, frequent cleaning and other maintenance will be necessary.

UPG The gutter at the split roof is not draining properly because they are improperly sloped. The gutter should be reconfigured or an additional downspout should be installed. If not, frequent cleaning and other maintenance will be necessary.

Gutter slopes towards roof

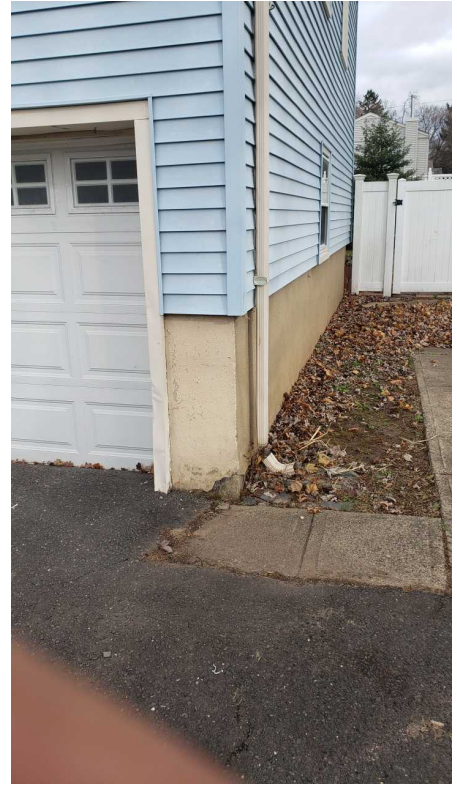
UPG 17: - Runoff water from the roof discharges next to the house. We recommend the downspouts be routed sufficiently away from the structure to prevent puddling, pooling, and saturation of the soil around the building.

UPG Runoff water from the roof discharges next to the house. We recommend the downspouts be routed sufficiently away from the structure to prevent puddling, pooling, and saturation of the soil around the building.

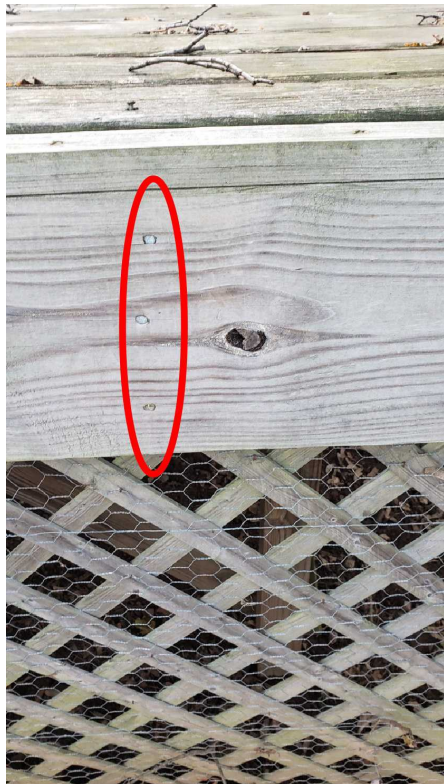
WARN 18: - The pool's deck is supported in a substandard manner with nails rather than joist hangers. We recommend repair or replacement in accordance with present standards.

WARN The pool's deck is supported in a substandard manner with nails rather than joist hangers. We recommend repair or replacement in accordance with present standards.

Nailed directly into joist with no hanger

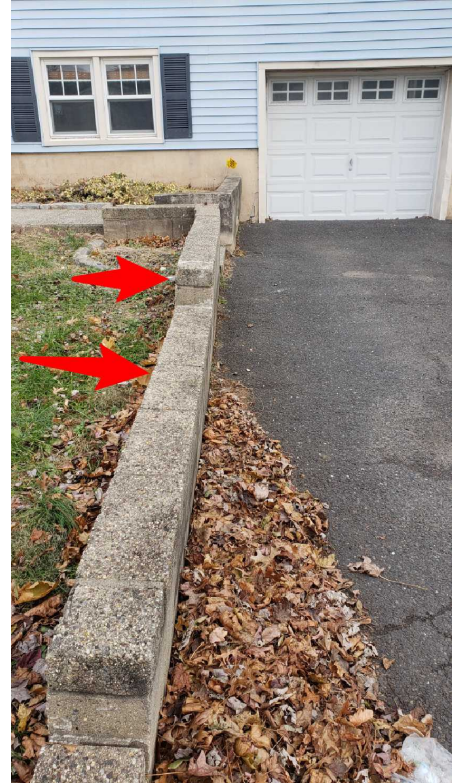
No weep holes and spalling

Wall is bowing outward

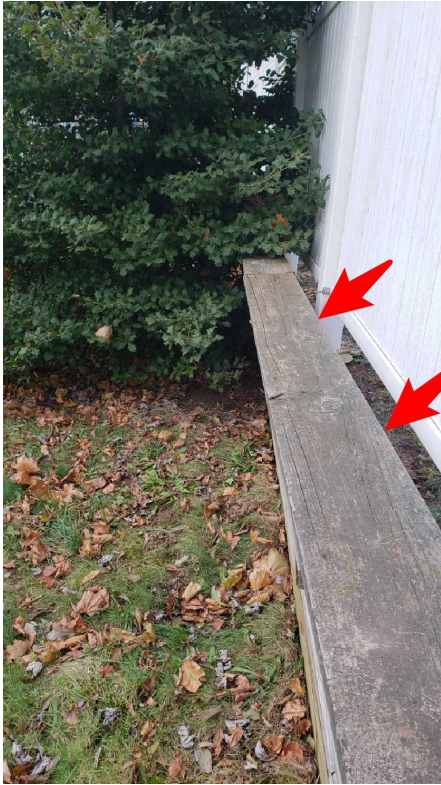
WARN UPG 20: - The structural retaining wall at the driveway is spalling and leaning. There are also no 'weep holes' near the base of the wall to facilitate drainage. The retaining wall should be monitored for further deterioration. If and when further deterioration or movement develops, repairs or replacement will be necessary.

UPG The structural retaining wall at the backyard is spalling and leaning. There are also no 'weep holes' near the base of the wall to facilitate drainage. The retaining wall should be monitored for further deterioration. If and when further deterioration or movement develops, repairs or replacement will be necessary.

Wall is bowing
