Confidential Inspection Report

LOCATED AT:
123 Sample Street
Sample Town, New Jersey 07080

INSPECTED ON:
Monday, January 01, 2018

Inspector, Mikhail Potros, P.E., CPI 24GI00173700
Precision Home Inspections LLC

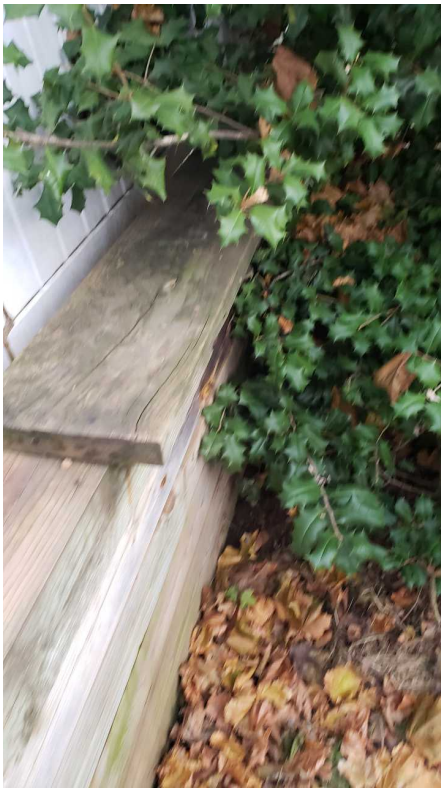
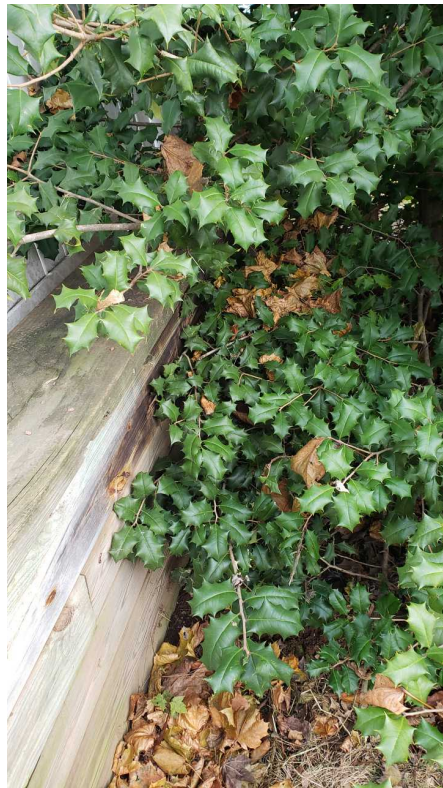
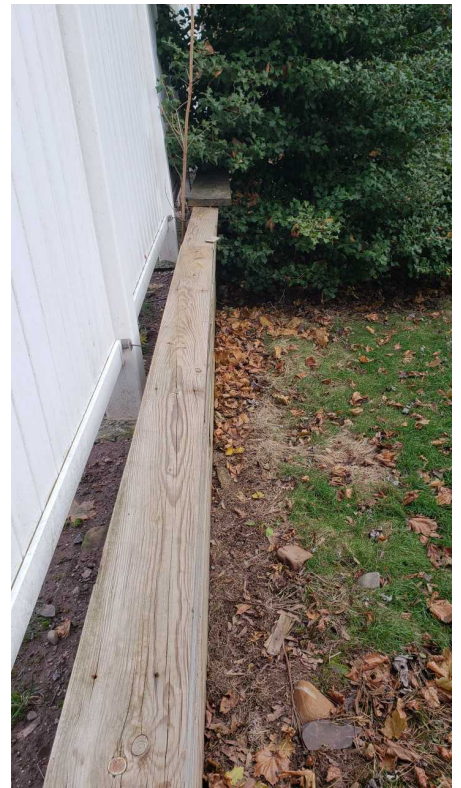
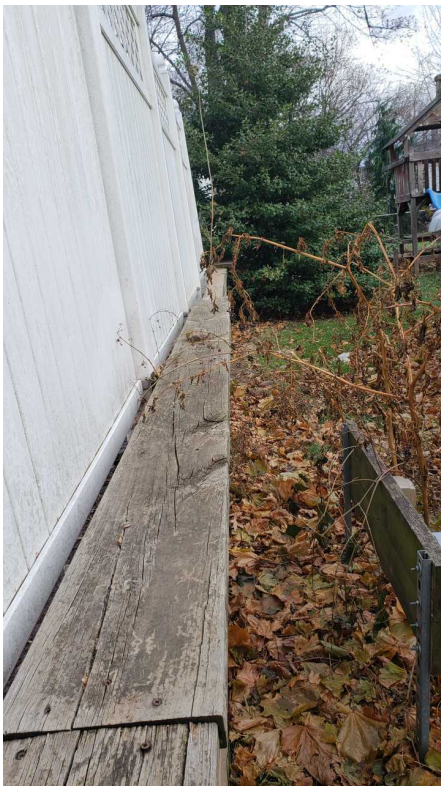
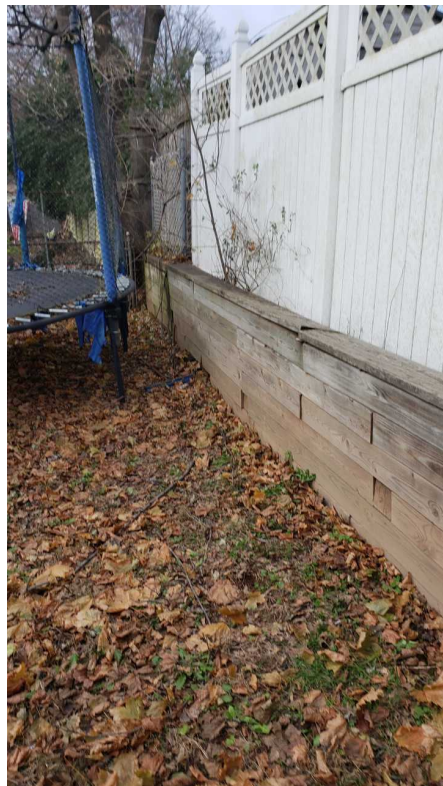
Direct wood to soil contact will eventually
rot away wall

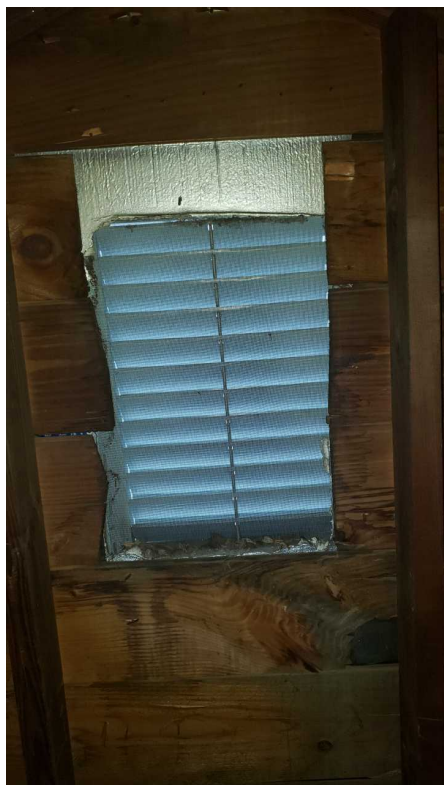
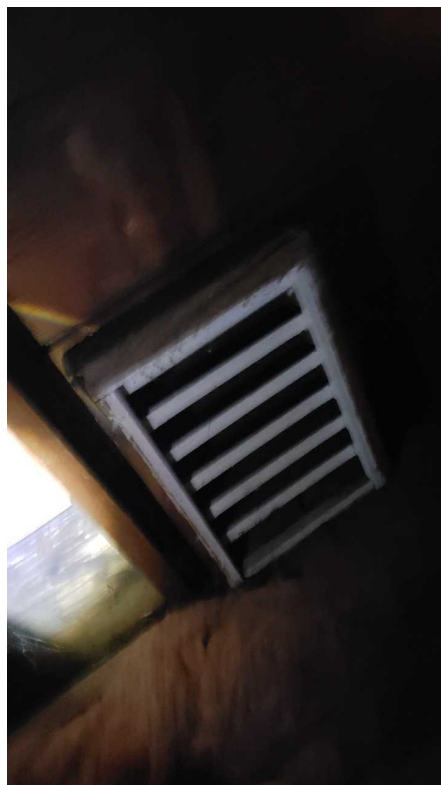
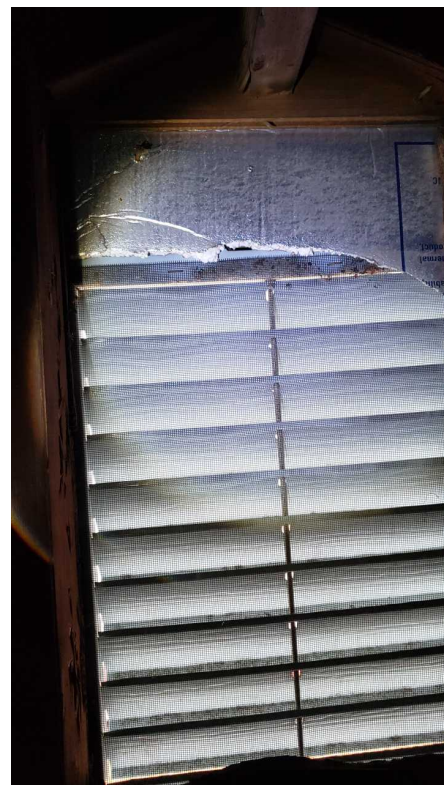
Gable vent frames within the attic spaces were observed to be broken

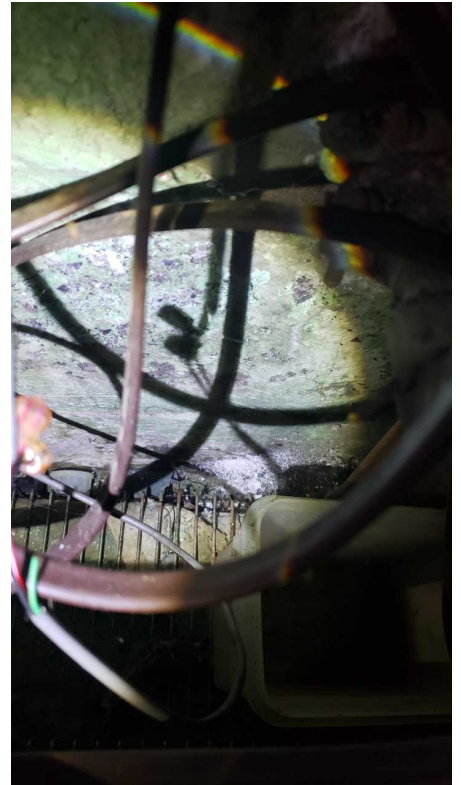
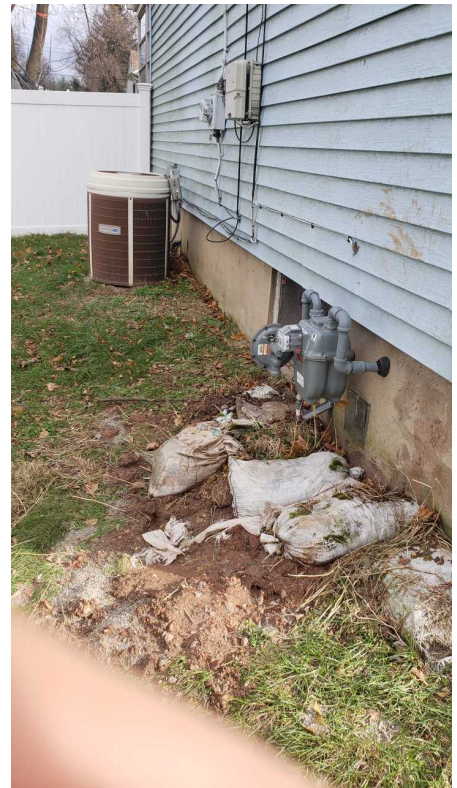
WARN UPG 21: - Based on evidence at time of inspection there was observed moisture in the basement floor in the front right corner of the house. It is highly suspect that this moisture is a consequence of the recent gas meter install. There was no moisture apparent on visible portions of the concrete block wall directly above the floor at this area. This area should be closely monitored and we recommend repair by a qualified and licensed contractor.

WARN **UPG** Based on evidence at time of inspection there was observed moisture in the basement floor in the front right corner of the house. It is highly suspect that this moisture is a consequence of the recent gas meter install. There was no moisture apparent on visible portions of the concrete block wall directly above the floor at this area. This area should be closely monitored and we recommend repair by a qualified and licensed contractor.

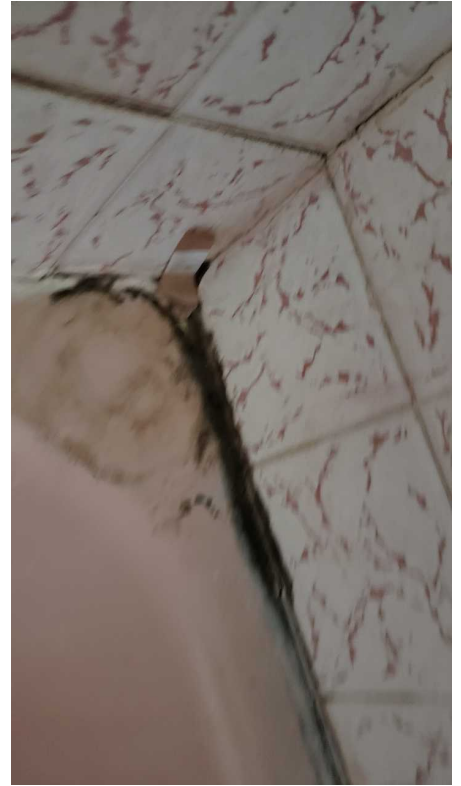
The shower walls are deteriorated and several tiles cracked. We recommend they be repaired or replaced.

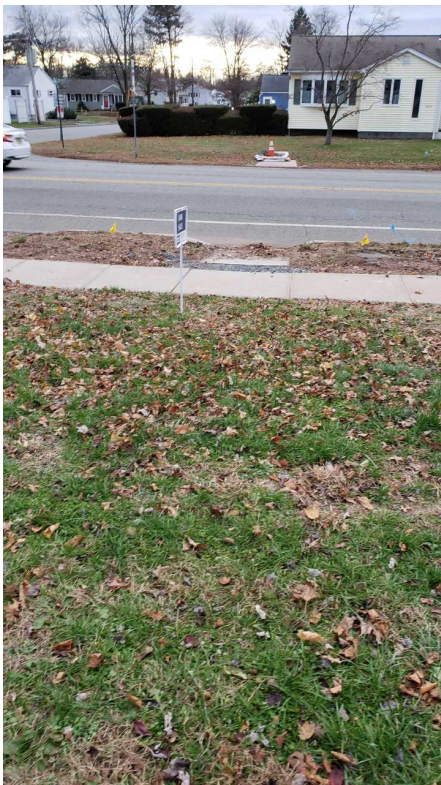
Gas line markout and asphalt patches located in front yard and sidewalk of the property
