Confidential Inspection Report

LOCATED AT:
123 Sample Street
Sample Town, New Jersey 07080

INSPECTED ON:
Monday, January 01, 2018

Inspector, Mikhail Potros, P.E., CPI 24GI00173700
Precision Home Inspections LLC

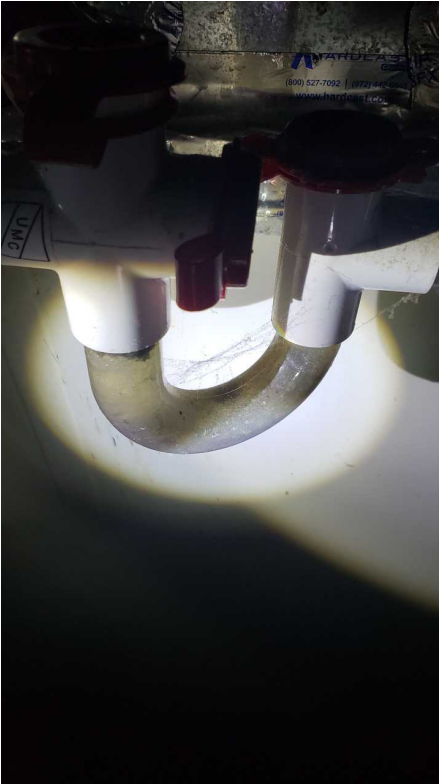
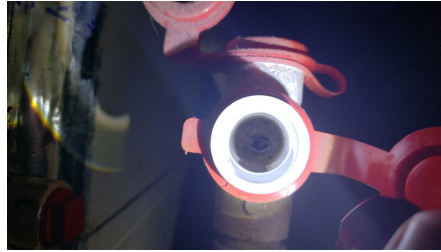
UPG Condensing drain line has significant sediment buildup and is in need of cleaning and servicing by qualified HVAC professional.

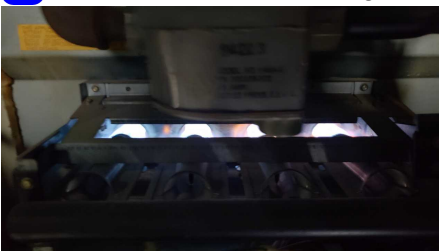
UPG The burner flame is irregular. We recommend the burners be cleaned and adjusted.

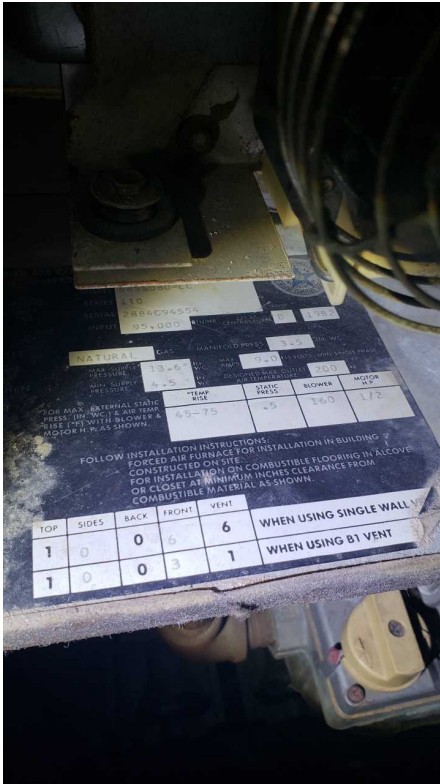
UPG Although we found no visible cracks, holes or other damage, due to the age and condition of the heat exchanger, the need for replacement of the furnace should be expected within the near future.

Data plate indicates the furnace is from 1982. This is at the end of its service life

For attention to the condition(s) noted above, we recommend servicing be performed by a licensed heating contractor.

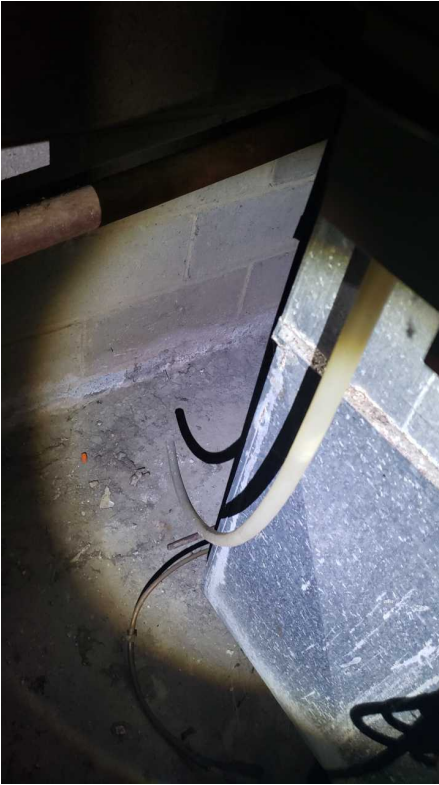
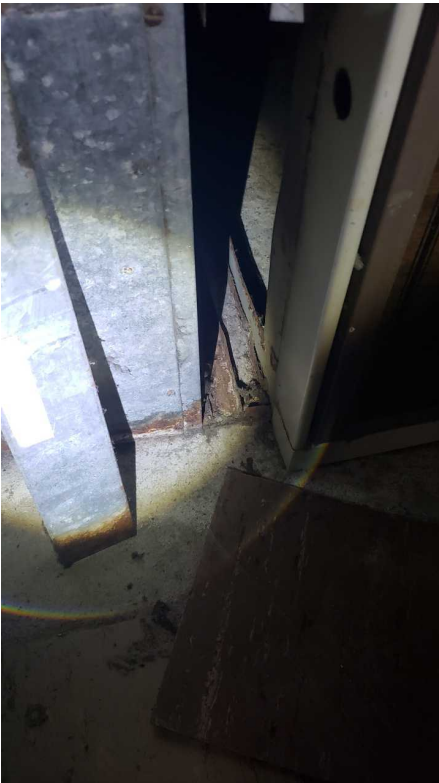
The return duct as well as bottom portions of the furnace unit showed significant signs of corrosion. This may have resulted from a previous humidifier leak. At the time of the inspection the humidifier was unplugged and drain line was cut. Further evaluation by a qualified licensed HVAC contractor is recommended.

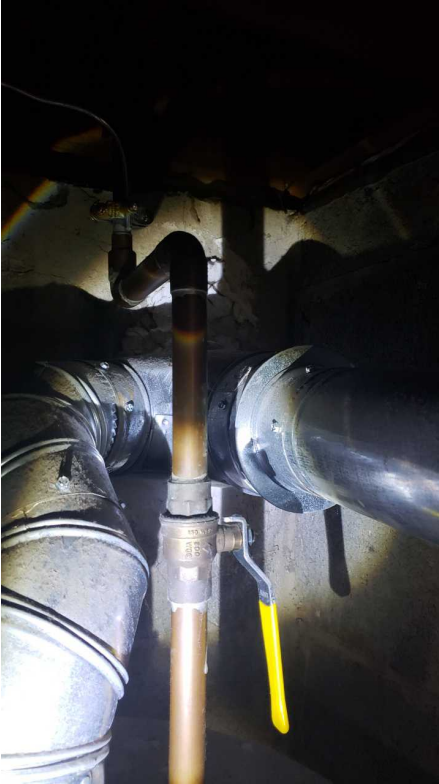
UPG The heating system vent connector is poorly connected at the opening into the brick chimney. We recommend the connection be made secure and air tight.

Furnace exhaust vent is tied into the water heater vent rather than directly into the chimney under the water heater exhaust

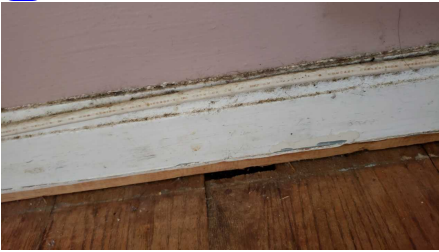
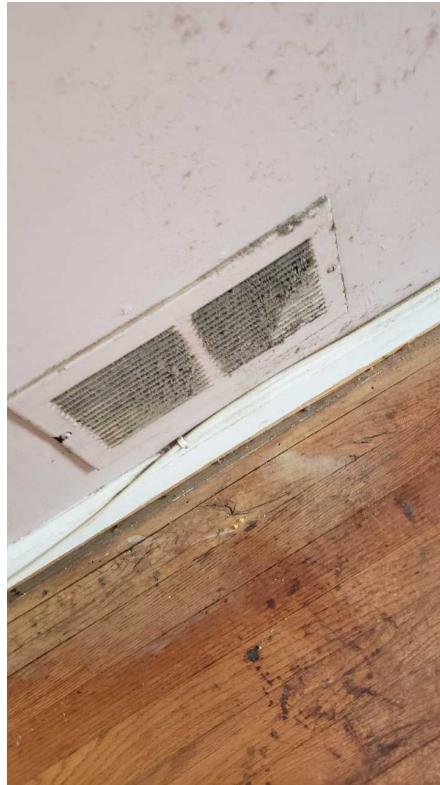
UPG There is debris in the ducts. We recommend the ducts be cleaned of all debris.

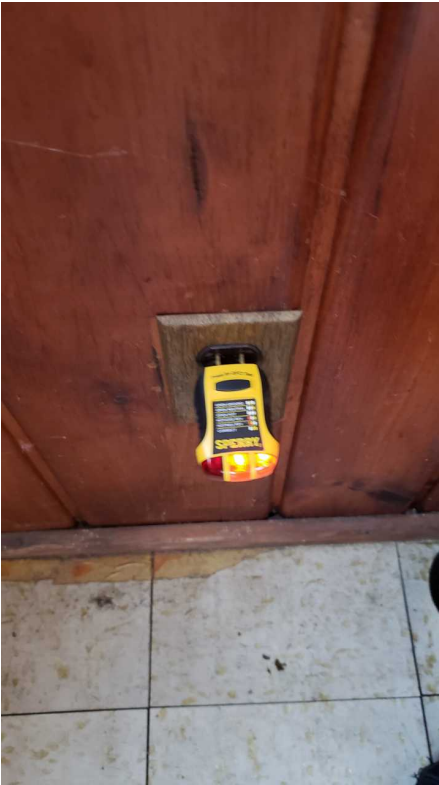
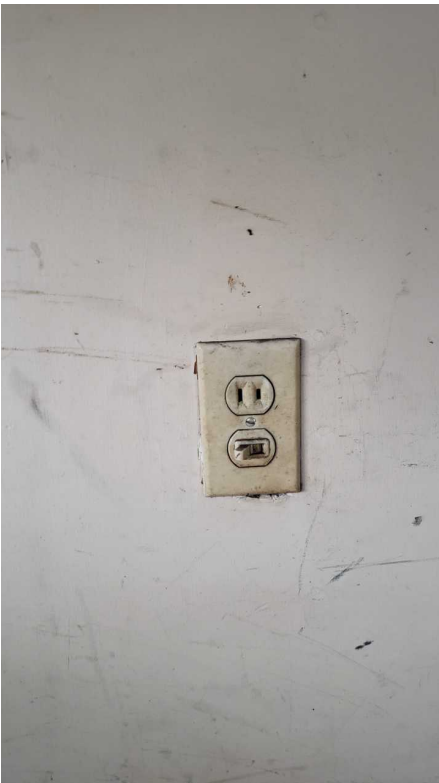
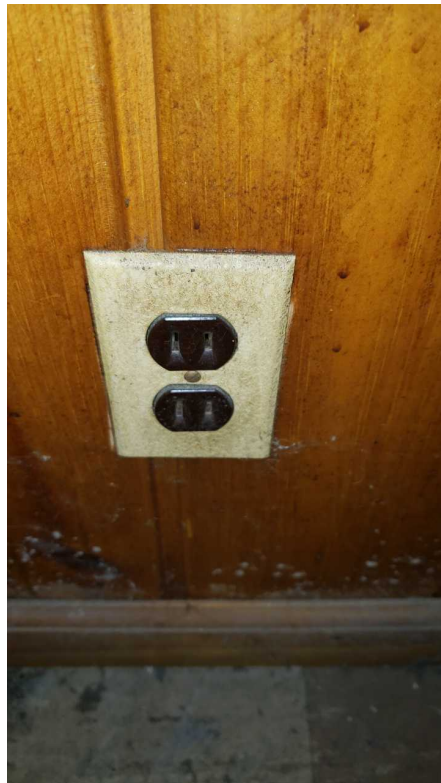
WARN **UPG** The receptacles throughout the structure are a combination of 2-wire and 3-wire types, with grounded and ungrounded circuitry, indicating installation at different times. The tested receptacles properly matched their wire type although upgrade of 2 prong receptacles to include grounding is recommended.

For attention to the condition(s) noted above, and/or cost estimates, if necessary, we recommend the advice and services of a licensed electrical contractor.

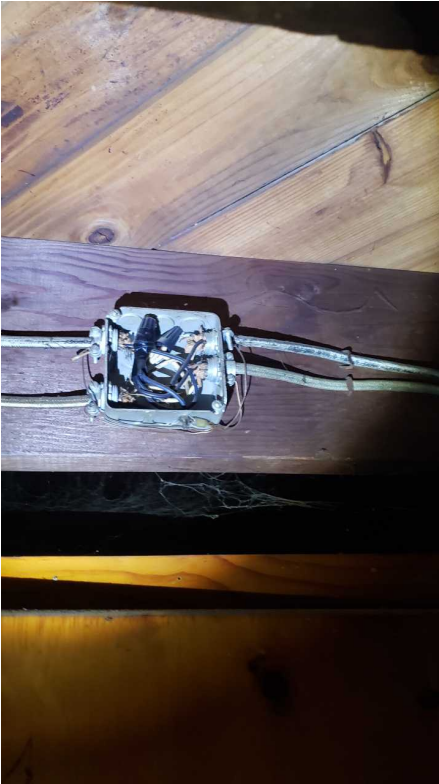
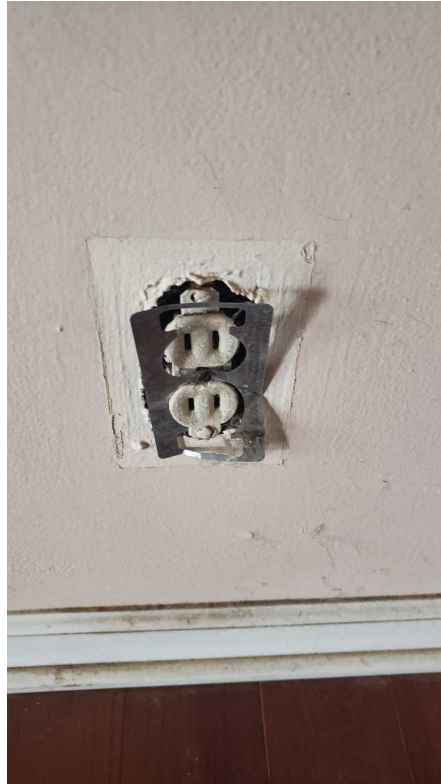
UPG Some of the receptacles are missing cover plates. We recommend they be replaced in the course of maintenance to reduce the risk of electrical shorts and hazardous shocks.

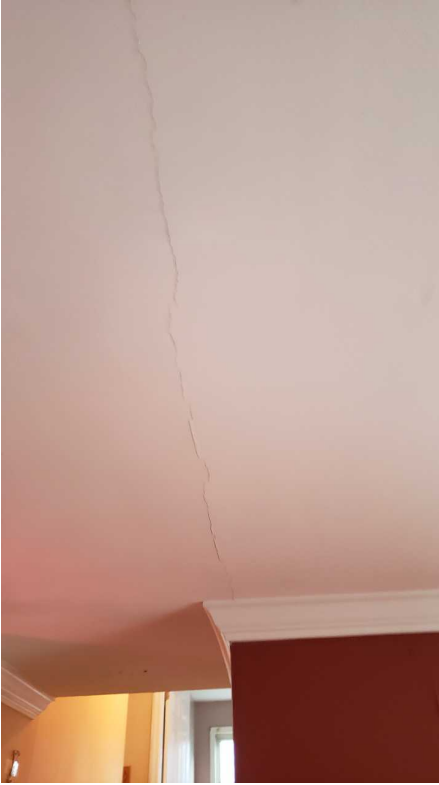
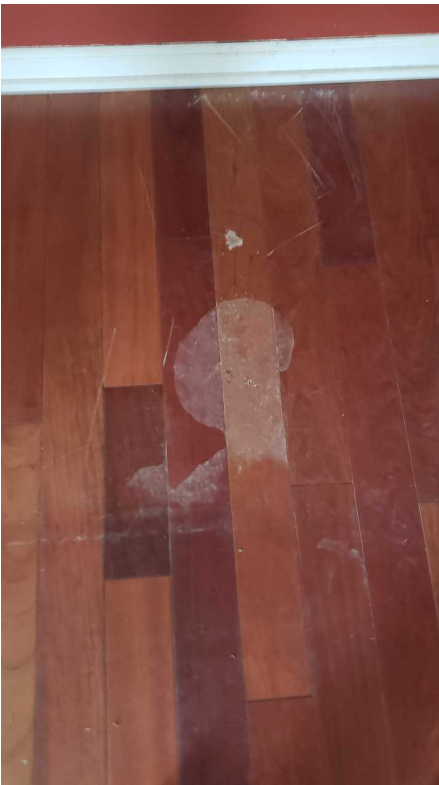
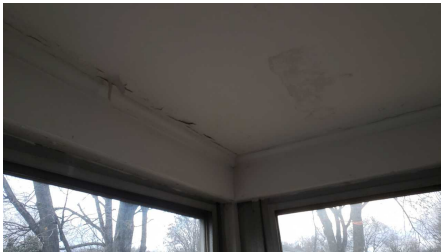
UPG There are minor cracks in the walls and/or ceilings. This is a common condition with this type of construction and does not indicate a structural deficiency. The cracks should be repaired and painted over.

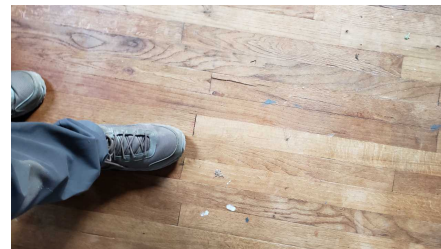
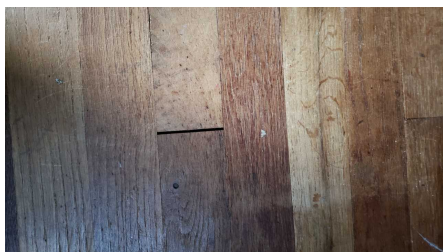
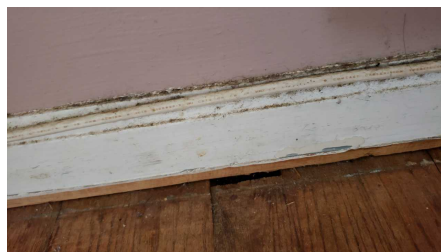
Portions of the floors are worn. We recommend refinishing to protect the wood and for a better appearance.

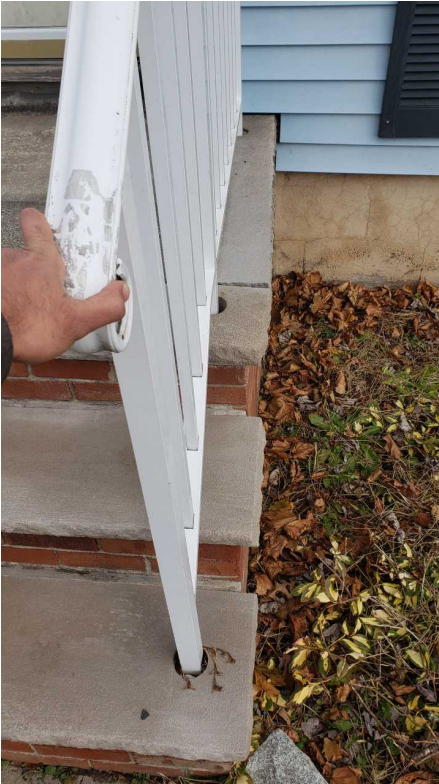
The left side railing at the entrance is not sturdy enough to resist a person's weight. We recommend that the railing be reinforced or replaced in accordance with present standards.

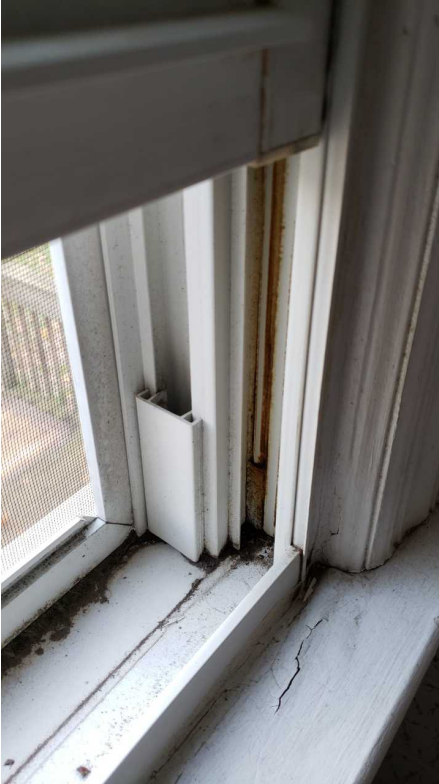
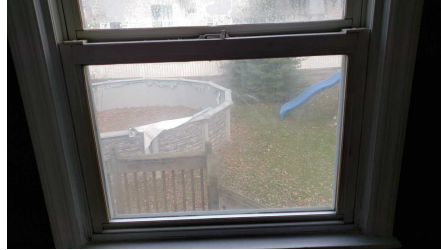
UPG The operation of the sliding windows is rough. We recommend they be cleaned, lubricated, and adjusted for smoother operation.

Window doesn't remain open. Broken latches

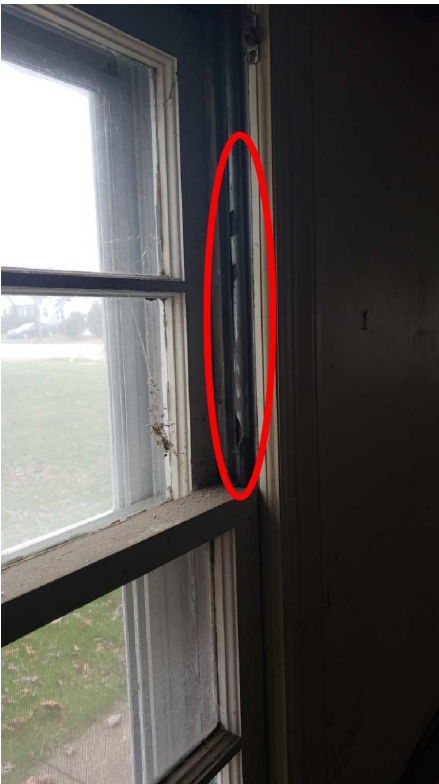
Broken spring

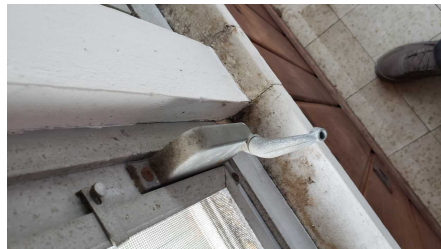
Windows in the rear sunroom are difficult to open

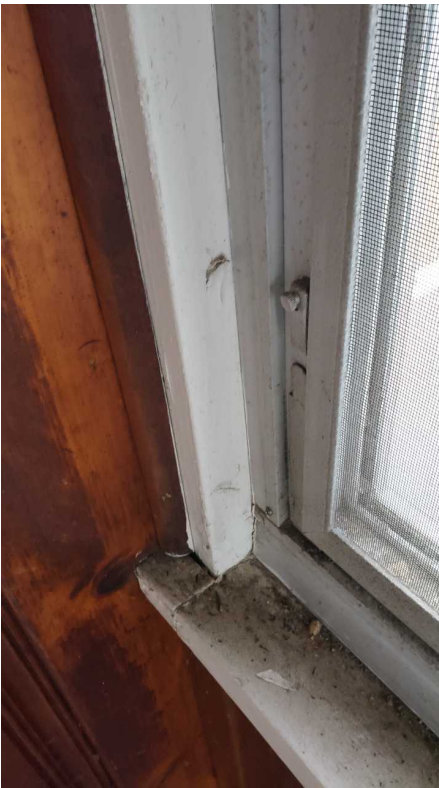
Cracked window

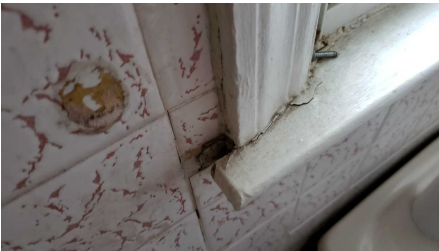
Screens and joints on several of the windows are slightly damaged and or missing. We recommend they be repaired or replaced.

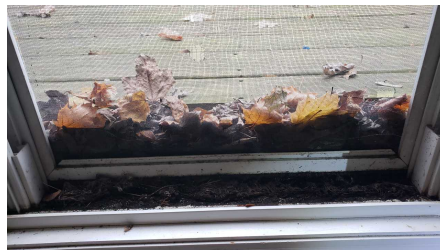
The window in the lower level bathroom is in a very bad location and shows previous entrance of debris, leaves, and moisture runoff from the adjacent deck.

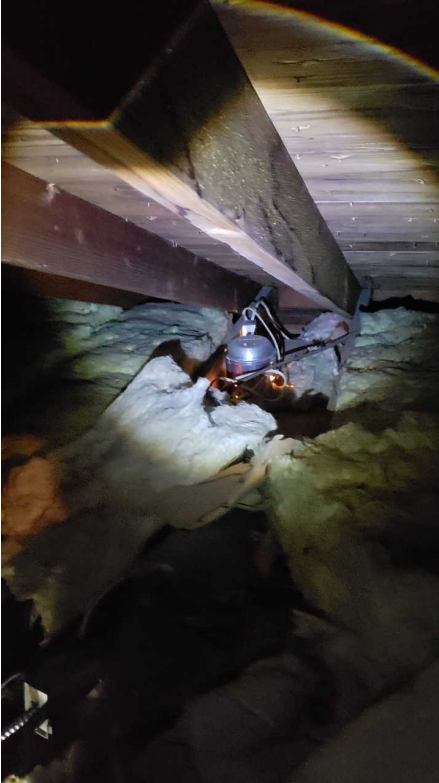
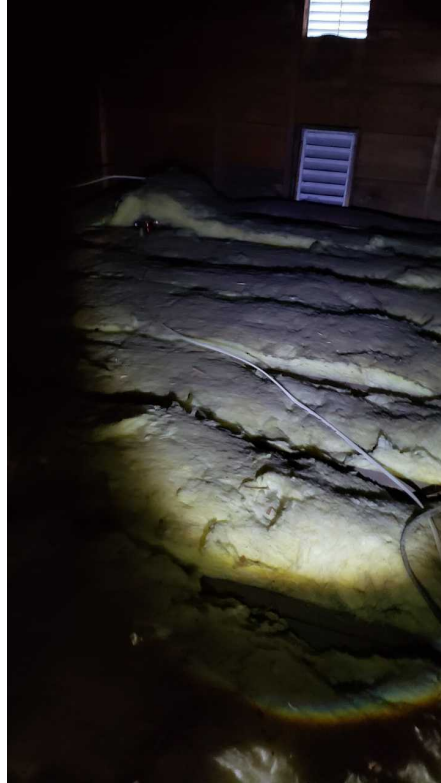
The insulation is installed in a substandard manner. We recommend it be reworked or replaced in accordance with accepted standards.

The recessed lights are covered with insulation and are a potential fire hazard. We recommend that barriers be provided over and around the lights in accordance with local standards and manufacturer's specifications and/or replace bulbs with newer LED lights.

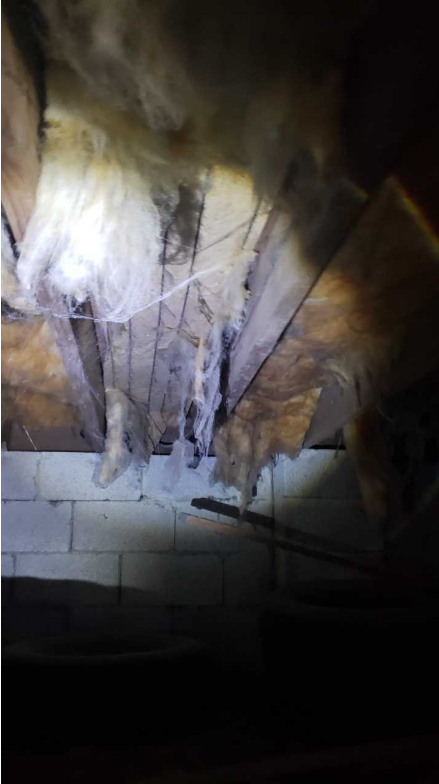
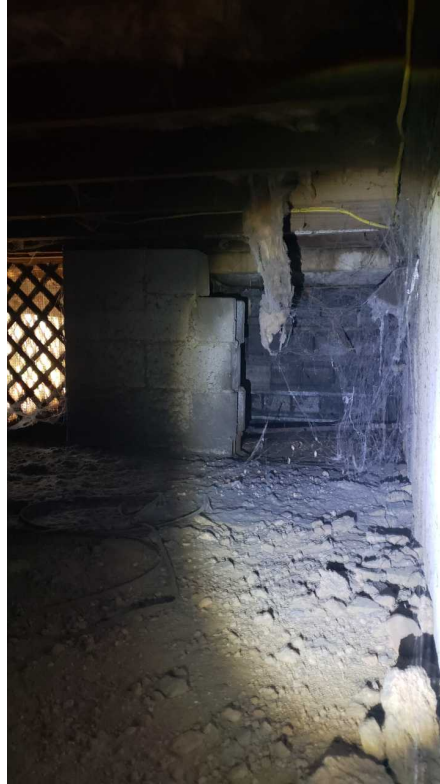
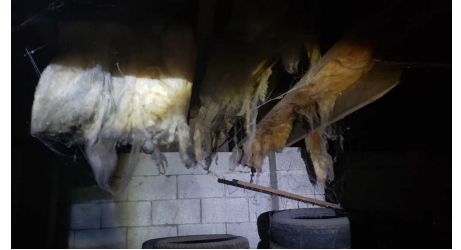
UPG 10: - The floor insulation is damaged and appears to be water damaged in the crawlspace. We recommend it be replaced.

UPG The floor insulation is damaged and appears to be water damaged in the crawlspace. We recommend it be replaced.

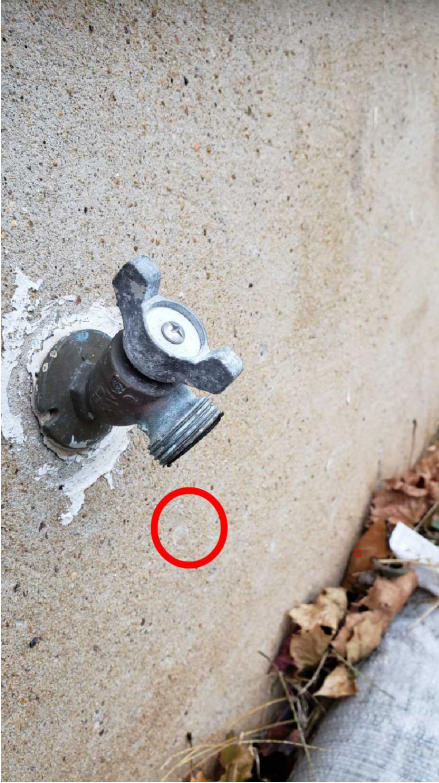
UPG The plumbing fixtures, although operating, are deteriorated and in need of replacement. Kitchen sink has hot water reversed. And bathroom fixtures show signs of corrosion/oxidation, mildew, and missing /broken valve controls. Routine maintenance will keep them functional and maximize their useful life.

Observed dripping

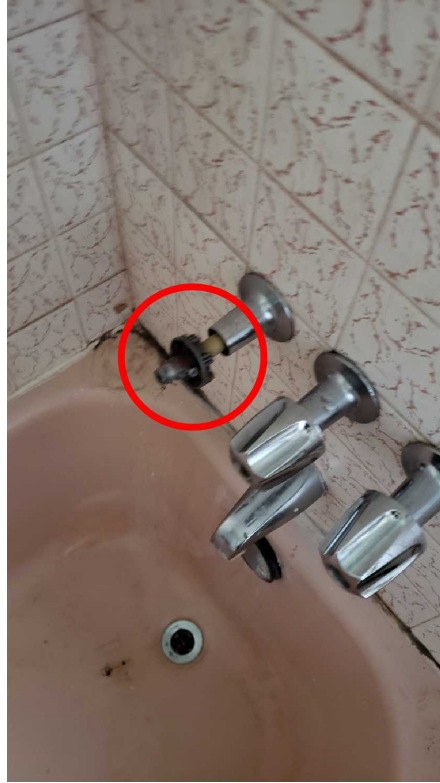
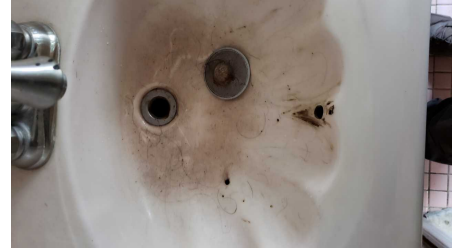
Clogged and stained

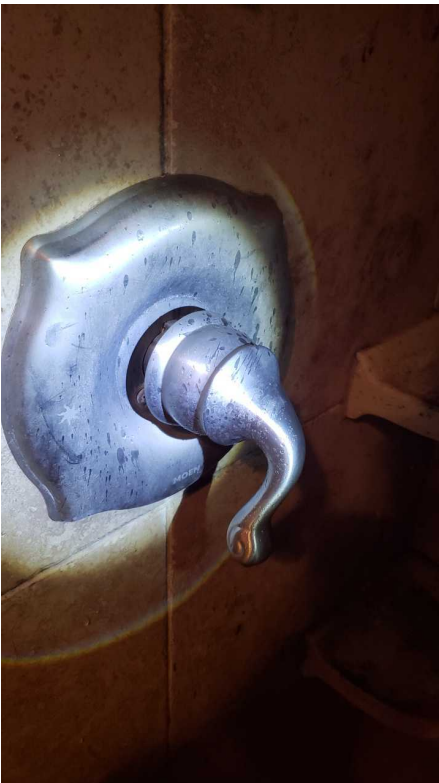
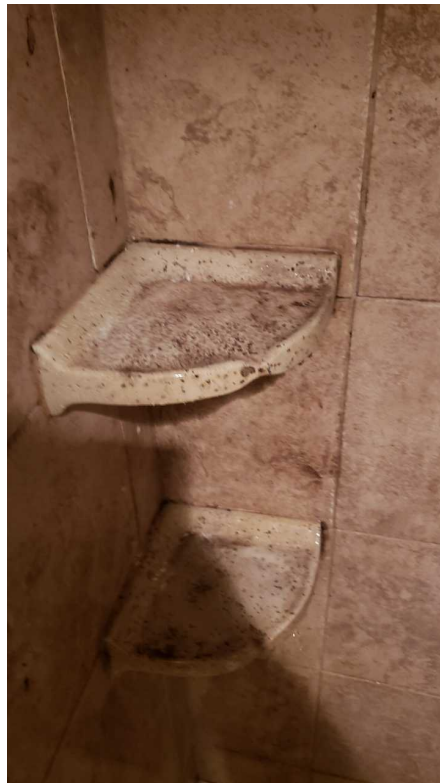
Missing valve handle

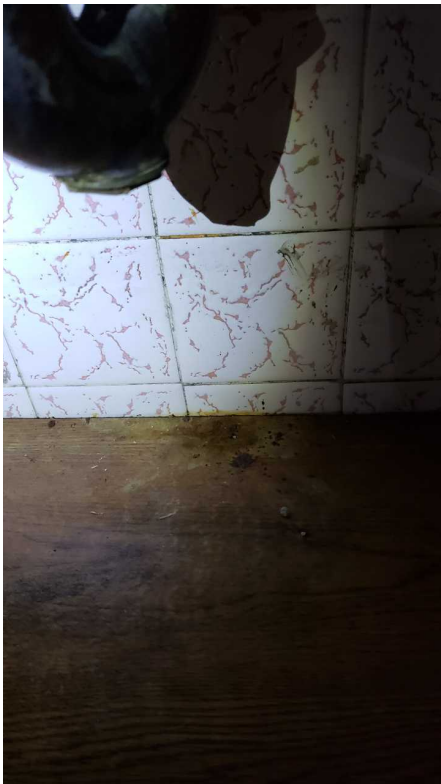
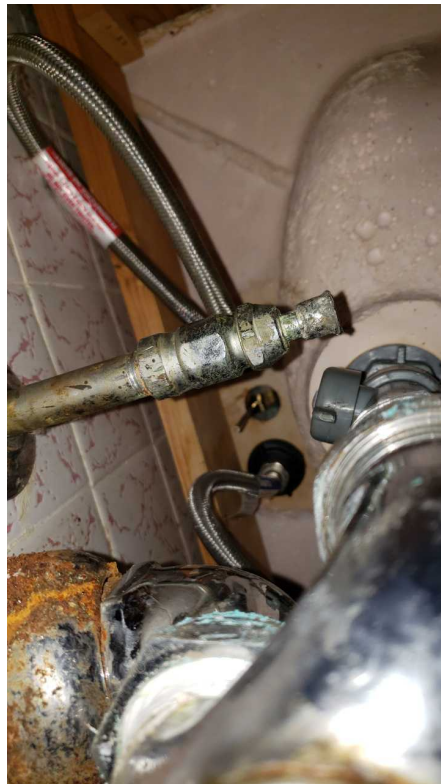
UPG Staining was present at the several sinks, suggesting prior leakage. These areas should be monitored for signs of active leakage.

Corrosion on drain

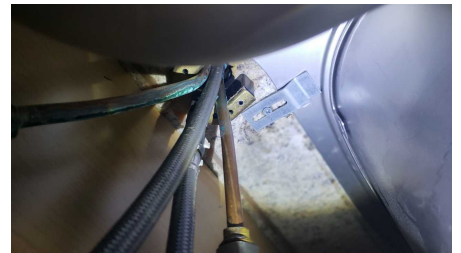
Corrosion on supply lines in kitchen

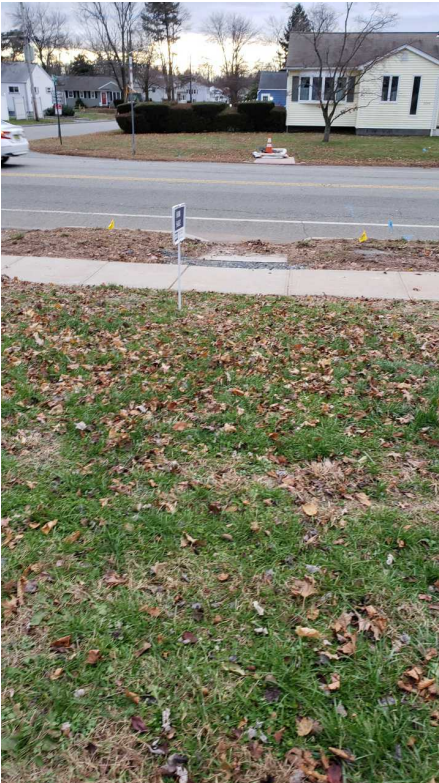
Gas line markout and asphalt patches located in front yard and sidewalk of the property

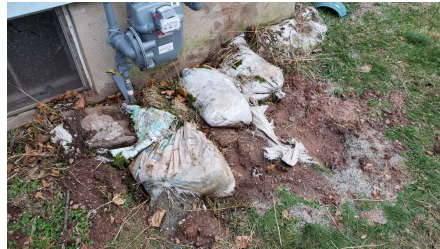
Proper compaction is suspect, observed leak in basement

WARN **UPG** Based on evidence at time of inspection there was observed moisture in the basement floor in the front right corner of the house. It is highly suspect that this moisture is a consequence of the recent gas meter install. There was no moisture apparent on visible portions of the concrete block wall directly above the floor at this area. This area should be closely monitored and we recommend repair by a qualified and licensed contractor.

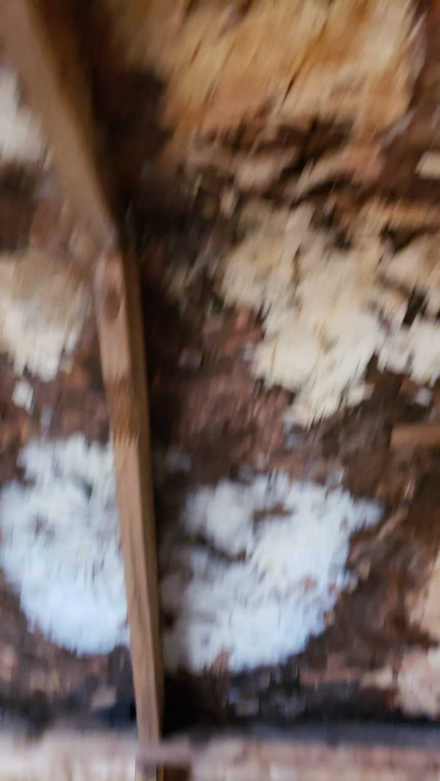
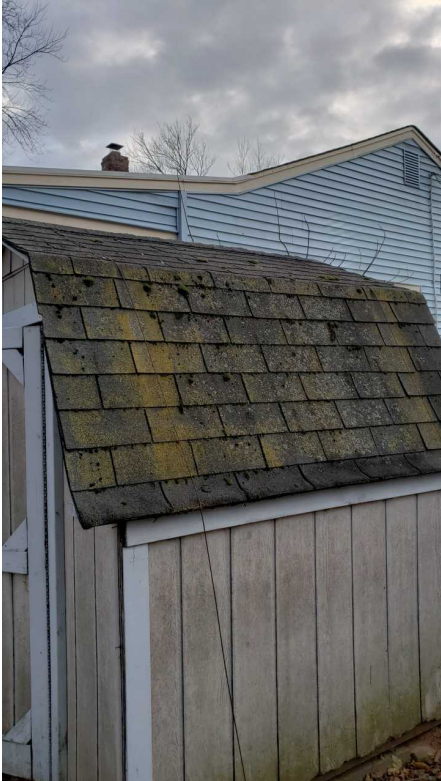
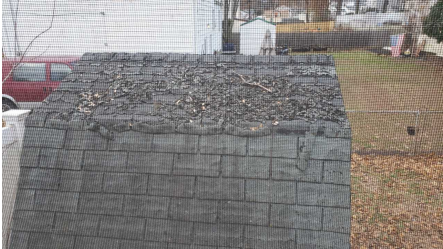
WARN The shingles and roof of the shed are long past their useful service life and extensive deterioration is evident. Roof replacement at the earliest opportunity is recommended.

UPG The condition(s) and/or configuration noted above is conducive to moisture penetration and leakage. We recommend the advice and services of a licensed roofing contractor.

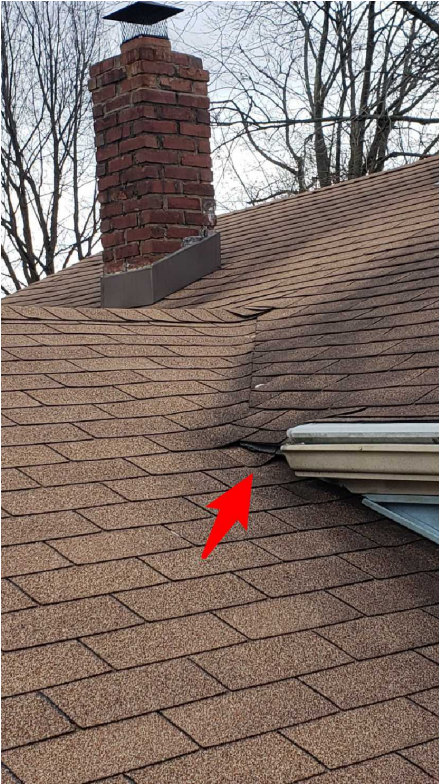
Pitched onto roof. In need of repair. Leak observed below this area

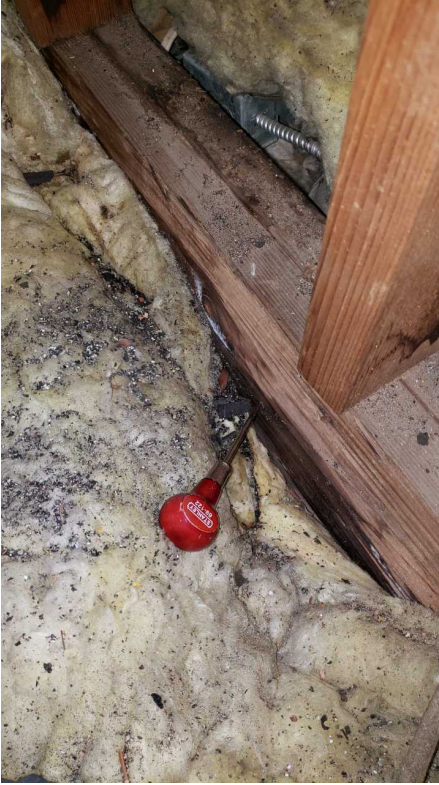
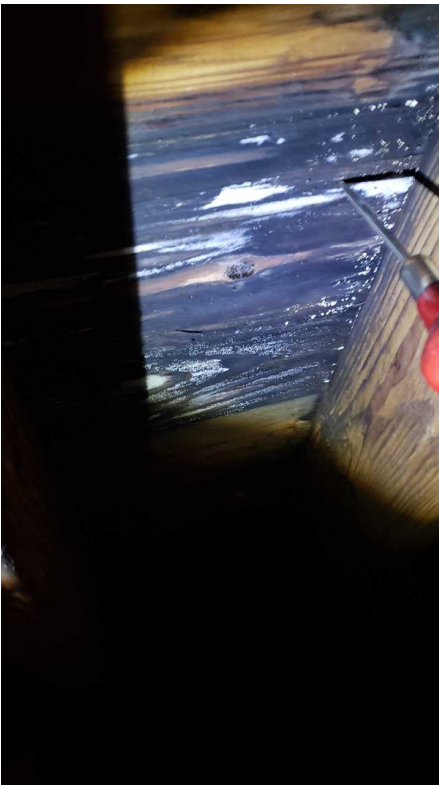
In addition to the condition(s) noted, there is evidence of leakage on the underside of the roof. The source of the leak should be found and repaired. We recommend the advice and services of a licensed roofing contractor.

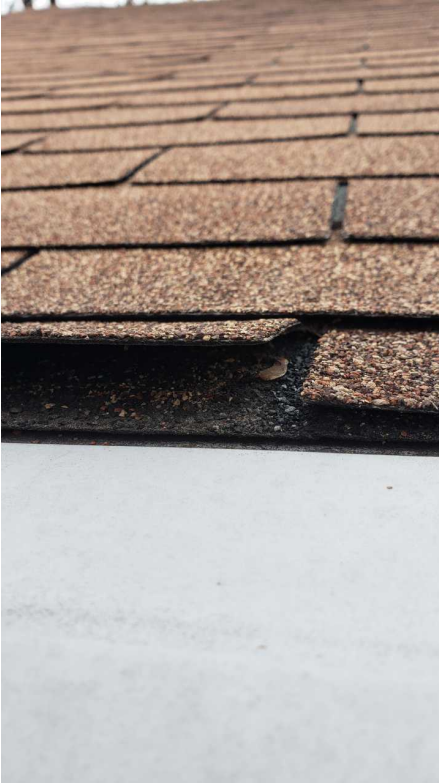
Note that no drip edge was installed, which improves efficiency of water shedding at the roof edges.

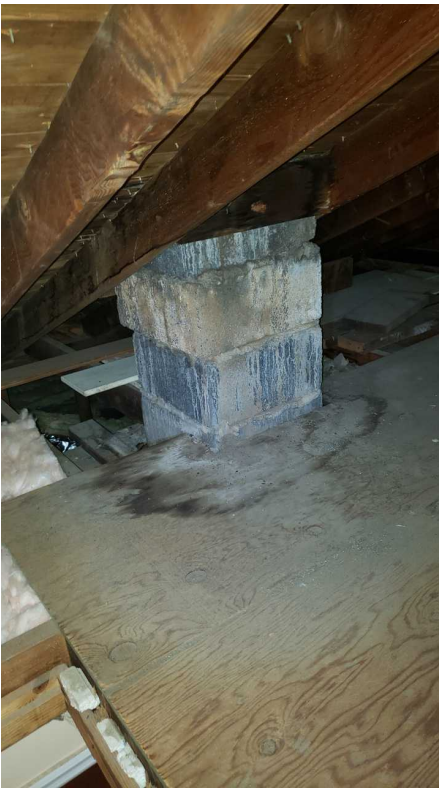
Evidence of previous leak around chimney

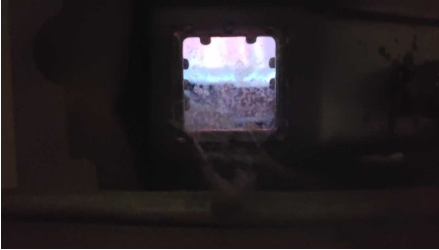
UPG The burner flame is yellow tipped, suggesting too little primary air, clogged burner ports, misaligned burner orifices, and/or a clogged draft hood. We recommend that the unit be serviced, cleaned and tuned.

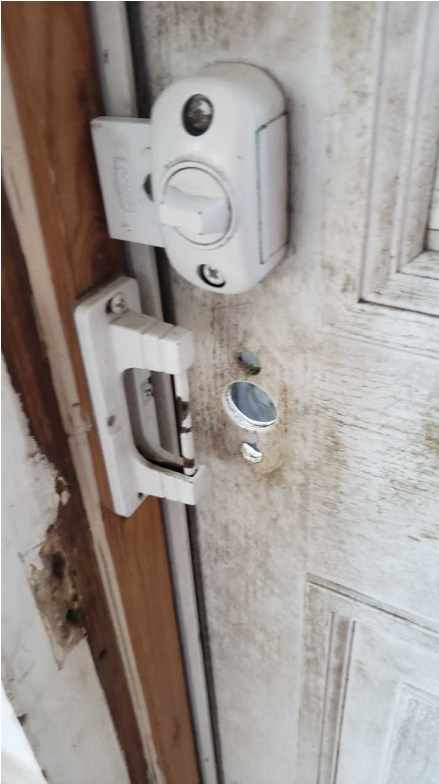
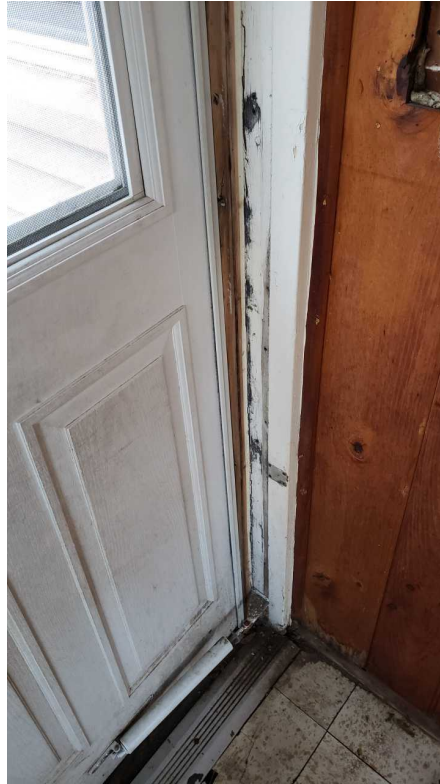
The rear patio door is damaged. We recommend it be replaced.

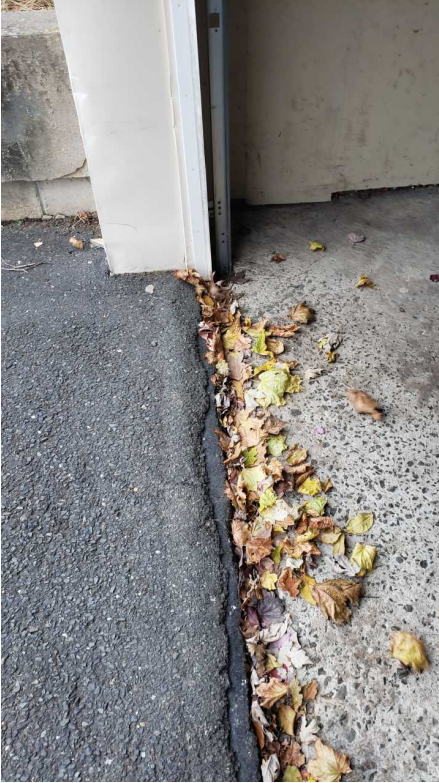
UPG Grading is sloped toward the garage. Low spots and negative grading promote water accumulation near the building, leading to foundation problems. Regrading or proper drainage would help ensure that surface water flows away from the structure.

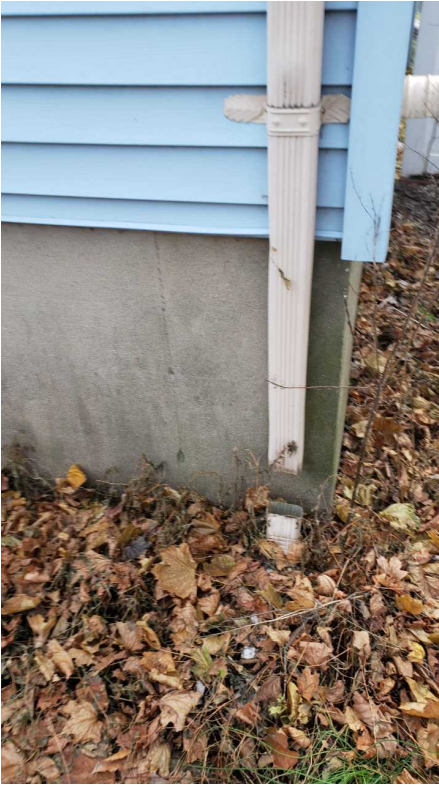
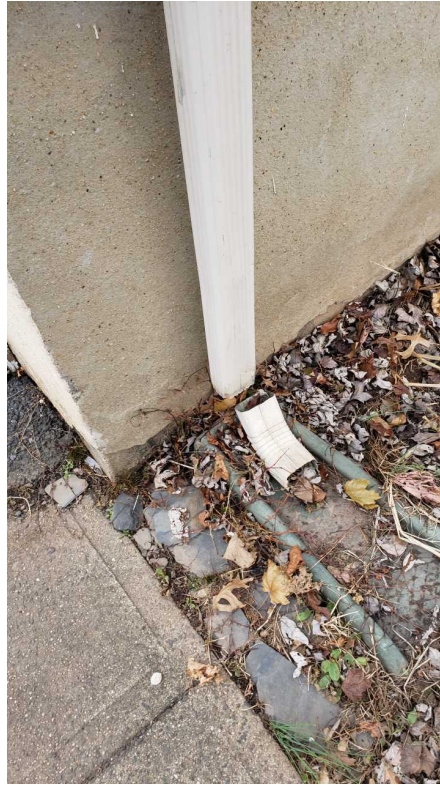
UPG Runoff water from the roof discharges next to the house. We recommend the downspouts be routed sufficiently away from the structure to prevent puddling, pooling, and saturation of the soil around the building.

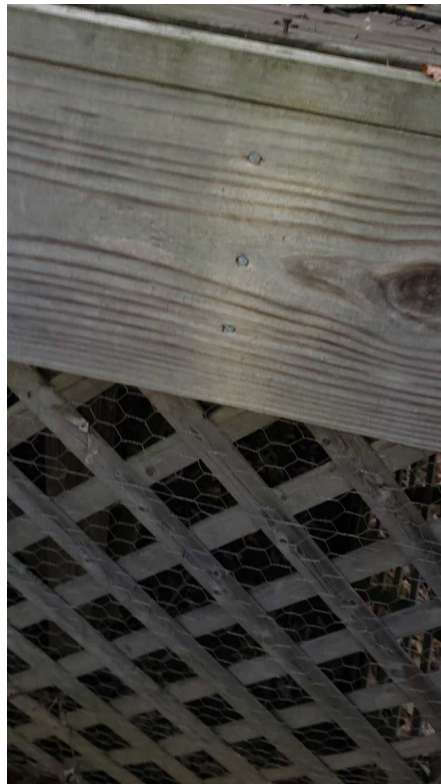
WARN The pool's deck is supported in a substandard manner with nails rather than joist hangers. We recommend repair or replacement in accordance with present standards.

Nailed directly into joist with no hanger

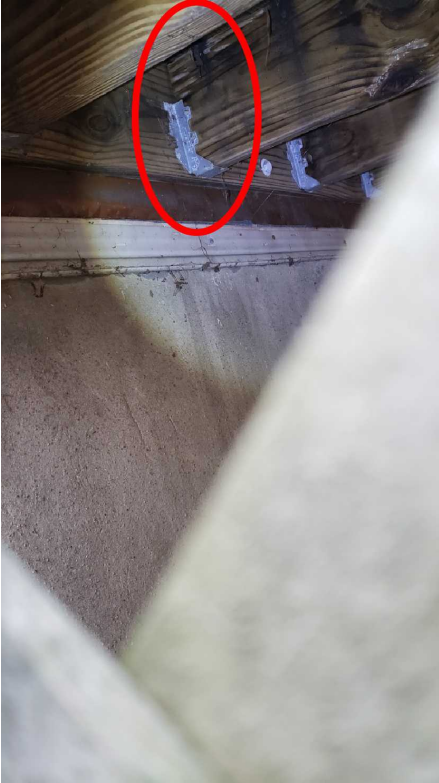
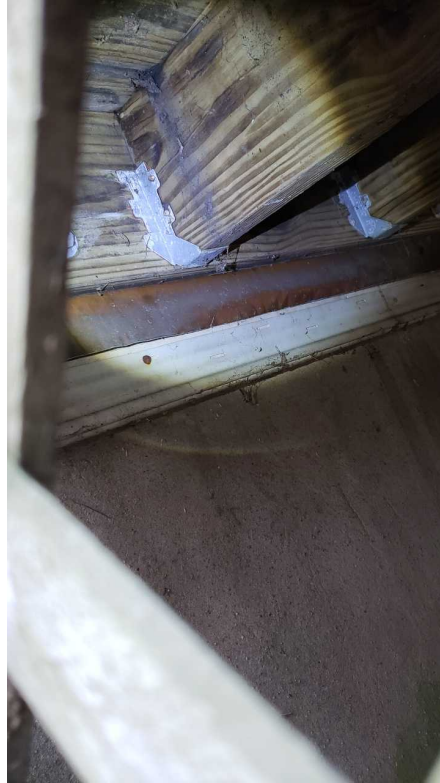
Although there was no accessible point of entry to fully access under the deck. The deck joists were observed to be supported by substandard joist hangers. Present standards require that joist hangers be the full depth of the joist. We recommend joist hangers be upgraded.

Substandard joist hanger. Should be full depth of joist

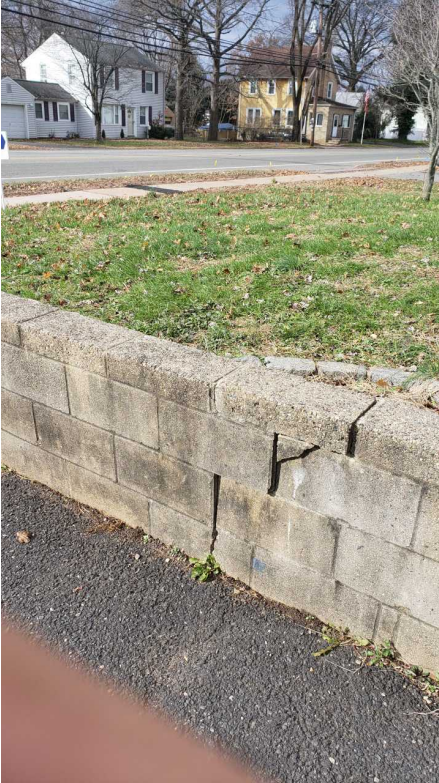
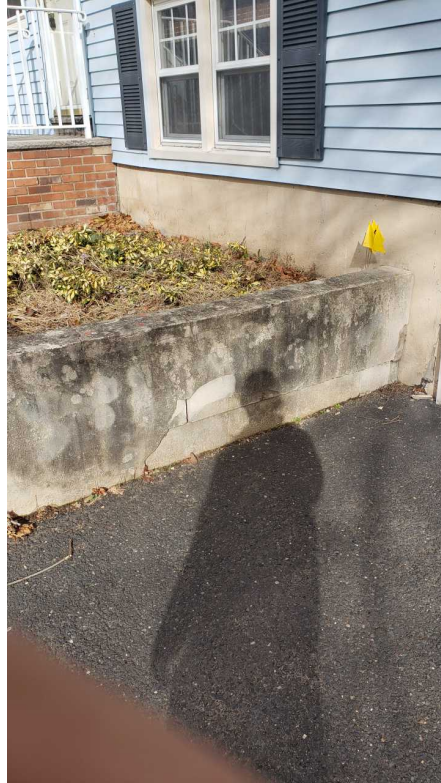
WARN **UPG** The structural retaining wall at the driveway is spalling and leaning. There are also no 'weep holes' near the base of the wall to facilitate drainage. The retaining wall should be monitored for further deterioration. If and when further deterioration or movement develops, repairs or replacement will be necessary.

No weep holes and spalling

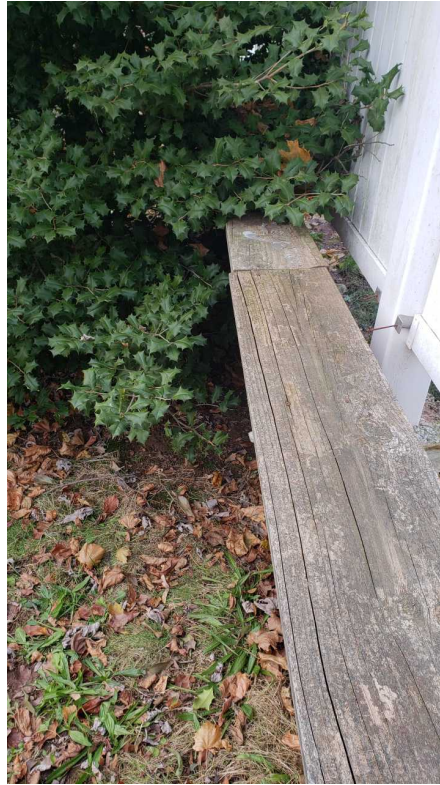
UPG The structural retaining wall at the backyard is spalling and leaning. There are also no 'weep holes' near the base of the wall to facilitate drainage. The retaining wall should be monitored for further deterioration. If and when further deterioration or movement develops, repairs or replacement will be necessary.

Wall is bowing

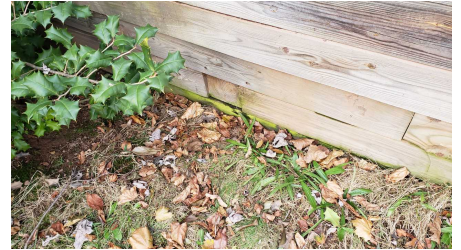
Direct wood to soil contact will eventually
rot away wall

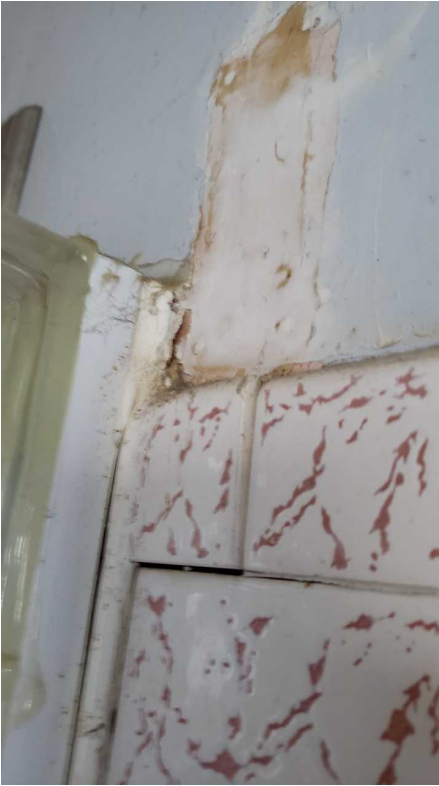
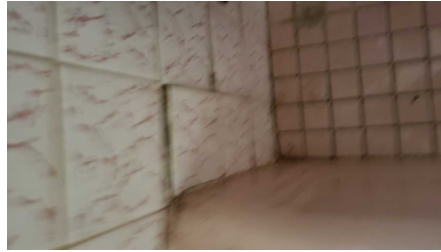
The shower walls are deteriorated and several tiles cracked. We recommend they be repaired or replaced.

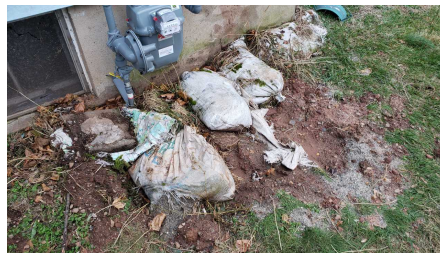
Proper compaction is suspect, observed leak in basement
